Area
TC01
 Machine Id
TC01 10 Inch Top

Component
Gearbox
 Fluid
TRIBOL GEAROIL 1100/320 (--- LTR)

Customer Id: GOONAP
 Sample No.: WC22086776
 Lab Number: 01670697
 Test Package: IND 2

OIL ANALYSIS REPORT

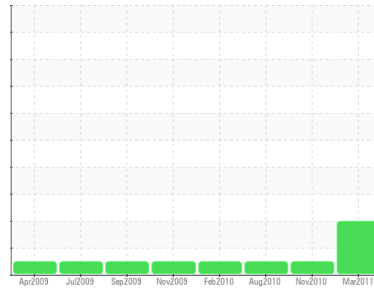
Sample Rating Trend

▲ Ferrous Alloys

Sample Status				ABNORMAL	NORMAL	NORMAL
Iron	ppm	ASTM D5185(m)		▲ 234	134	158
White Metal	scalar	Visual*	NONE	▲ MODER	LIGHT	LTMOD
PrtFilter					no image	no image

We recommend that you drain the oil from the component if this has not already been done. We recommend an early resample to monitor this condition.

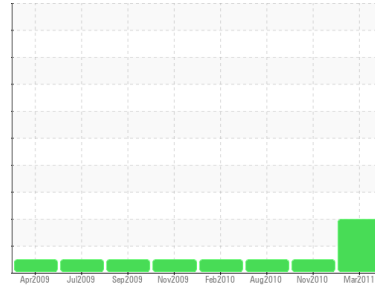
Sample Rating Trend

A sharp increase in the iron level is noted. Light concentration of visible metal present. Gear wear is indicated.

The oil is no longer serviceable as a result of the abnormal and/or severe wear.

We recommend that you drain the oil from the component if this has not already been done. We recommend an early resample to monitor this condition.
