Area
MANITOU FALLS GS
 Machine Id
FP2G4
 Component
Thrust Bearing
 Fluid
ESSO TERESSO ISO 46 (--- GAL)

Customer Id: ONTKEE
 Sample No.: WC0806469
 Lab Number: 02559004
 Test Package: IND 2

OIL ANALYSIS REPORT

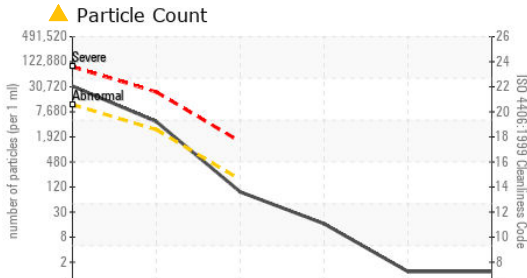
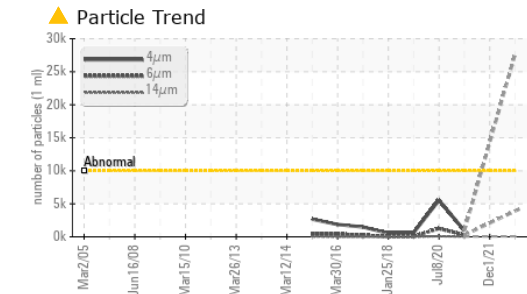
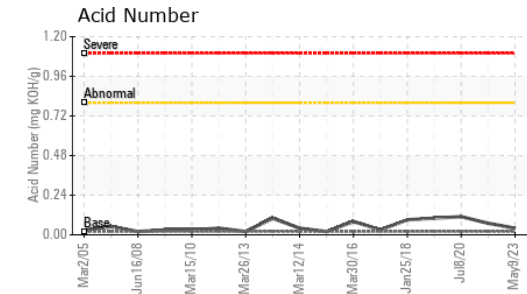
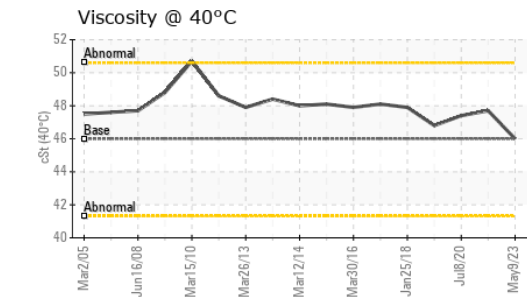
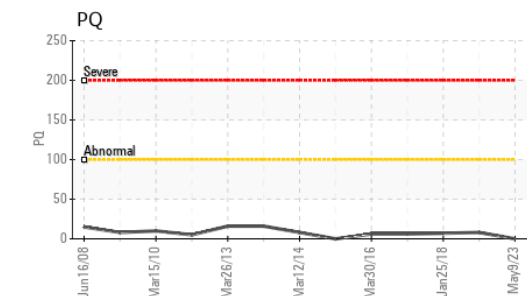
There is a moderate amount of silt (particulates < 14 microns in size) present in the oil.

FLUID CLEANLINESS	method	limit/base	current	history1	history2
Particles >4µm	ASTM D7647	>10000	▲ 27641	---	939
Particles >6µm	ASTM D7647	>2500	▲ 3906	---	276
Particles >14µm	ASTM D7647	>160	81	---	24
Particles >21µm	ASTM D7647	>40	14	---	4
Particles >38µm	ASTM D7647	>10	1	---	0
Particles >71µm	ASTM D7647	>3	1	---	0
Oil Cleanliness	ISO 4406 (c)	>20/18/14	▲ 22/19/14	---	17/15/12

We recommend you service the filters on this component. We recommend an early resample to monitor this condition. NOTE: Please provide information regarding reservoir capacity, filter type and micron rating with next sample.

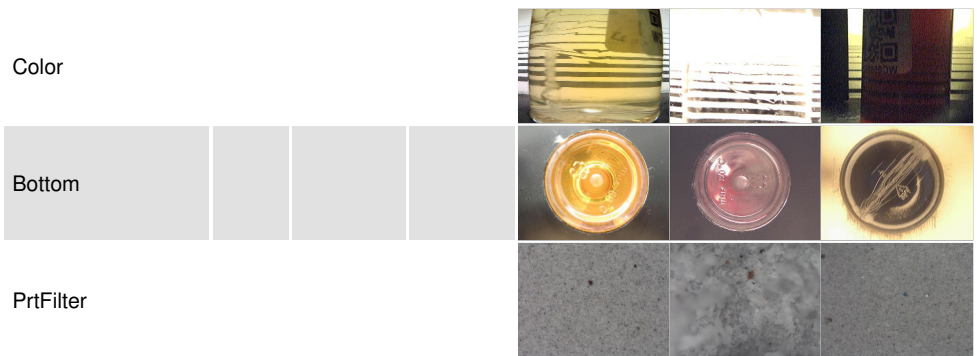
SAMPLE IMAGES	method	limit/base	current	history1	history2
---------------	--------	------------	---------	----------	----------

This is a baseline read-out on the submitted sample. {not applicable} a light concentration of debris was filtered from the sample. {not applicable}
