# PROBLEM SUMMARY

Machine Id  
**059**  
 Component  
**Hydraulic System**  
 Fluid  
**ESSO HYJET IV-A PLUS (--- GAL)**

Customer Id: KELMOU  
 Sample No.: WC0838479  
 Lab Number: 02575918  
 Test Package: IND 2

# OIL ANALYSIS REPORT

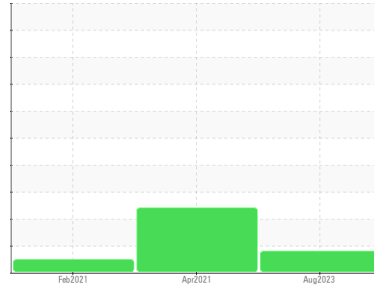
Sample Rating Trend

#### ▲ Additives

Sample Status				ATTENTION	ABNORMAL	NORMAL
Phosphorus	ppm	ASTM D5185(m)	37	▲ 29387	▲ 35127	44986
Sulfur	ppm	ASTM D5185(m)	220	▲ 594	▲ 798	336

Confirm the source of the lubricant being utilized for top-up/fill. Resample at the next service interval to monitor. NOTE: Please provide information regarding reservoir capacity, filter type and micron rating with next sample.

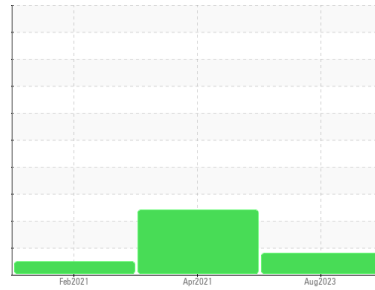
## Sample Rating Trend

Additive levels indicate the addition of a different brand, or type of oil. The AN level is acceptable for this fluid. The condition of the oil is suitable for further service.

Confirm the source of the lubricant being utilized for top-up/fill. Resample at the next service interval to monitor. NOTE: Please provide information regarding reservoir capacity, filter type and micron rating with next sample.
