# PROBLEM SUMMARY

Area  
**SAB1**  
 Machine Id  
**SAB1 G5**  
 Component  
**Thrust Bearing**  
 Fluid  
**PETRO CANADA TURBOFLO XL46 (1182 LTR)**

# OIL ANALYSIS REPORT

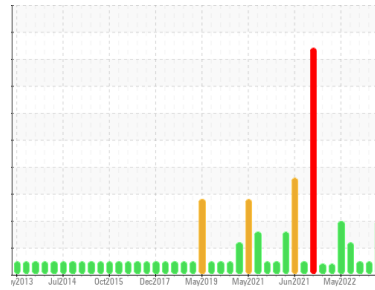
Sample Rating Trend

**VISUAL METAL**

Sample Status				<b>ABNORMAL</b>	NORMAL	NORMAL
Particles >4µm	ASTM D7647	>1300		▲ <b>1529</b>	689	412
Oil Cleanliness	ISO 4406 (c)	>17/15/12		▲ <b>18/15/10</b>	17/15/11	16/14/11
White Metal	scalar	Visual*	NONE	▲ <b>LIGHT</b>	NONE	NONE

We advise that you check for visible metal particles in the oil. We recommend you service the filters on this component. We recommend an early resample to monitor this condition.

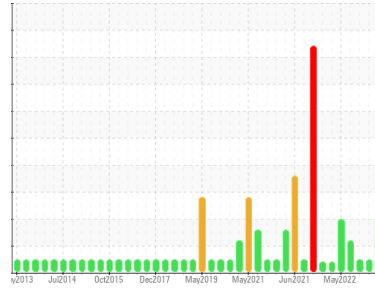
Sample Rating Trend

VISUAL METAL

Light concentration of visible metal present.

There is a light amount of silt (particulates < 14 microns in size) present in the oil.

The AN level is acceptable for this fluid. The condition of the oil is suitable for further service.

We advise that you check for visible metal particles in the oil. We recommend you service the filters on this component. We recommend an early resample to monitor this condition.
