Area
PLANT 7
 Machine Id
AHS SLT
 Component
1 Hydraulic System
 Fluid
COMMERCIAL OIL LUBRIKO AW 46 (100 LTR)

Customer Id: TAYSTO
 Sample No.: WC0754607
 Lab Number: 02590007
 Test Package: IND 2

OIL ANALYSIS REPORT

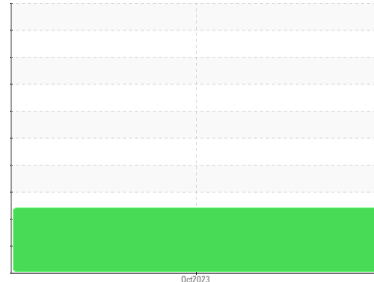
Sample Rating Trend

Sample Status				ABNORMAL	---	---
Particles >4µm		ASTM D7647	>5000	▲ 17061	---	---
Oil Cleanliness		ISO 4406 (c)	>19/17/14	▲ 21/17/9	---	---
White Metal	scalar	Visual*	NONE	▲ VLITE	---	---
Debris	scalar	Visual*	NONE	▲ VLITE	---	---
PrtFilter

We advise that you check all areas where contaminants can enter the system. We recommend you service the filters on this component. We recommend an early resample to monitor this condition. Please specify the component make and model with your next sample. We suspect that the abnormal contaminant(s) is the result of incorrect sampling technique. **DISCLAIMER:** Interpretation of results is based on the sample as received from the customer. The condition of the sample and the method of sampling cannot be verified.
