Machine Id
VOLVO EC160EL P96 (S/N VCEC160EK00310367)
 Component
Hydraulic System
 Fluid
PANOLIN HLP SYNTH 46 (--- GAL)

Customer Id: CLESAL
 Sample No.: WC0843720
 Lab Number: 02590078
 Test Package: IND 2

OIL ANALYSIS REPORT

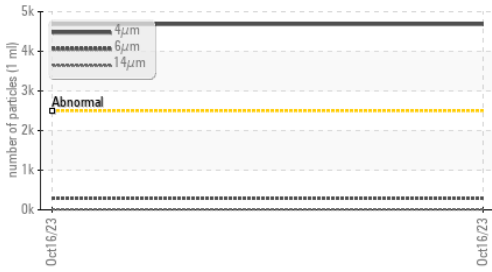
▲ Particle Trend

Sample Status	ATTENTION	---	---
Particles >4µm	ASTM D7647 >2500 ▲ 4685	---	---
Oil Cleanliness	ISO 4406 (c) >18/16/13 ▲ 19/15/11	---	---

Action	Status	Date	Done By	Description
Change Filter	---	---	?	We recommend you service the filters on this component.
Information Required	---	---	?	NOTE: Please provide information regarding reservoir capacity, filter type and micron rating with next sample.
