OIL ANALYSIS REPORT

Area
SAB2
 Machine Id
SAB2 G23
 Component
Turbine Bearing
 Fluid
ESSO TERESSO ISO 46 (273 LTR)

Ontario Power Generation
 NIAGARA PLANT GROUP, 14000 NIAGARA PKWY
 NIAGARA ON THE LAKE, ON
 CA L0S 1J0
 Contact: Alex Courtemanche
 alex.courtemanche@opg.com
 T: (905)357-0322
 F: (905)357-6558

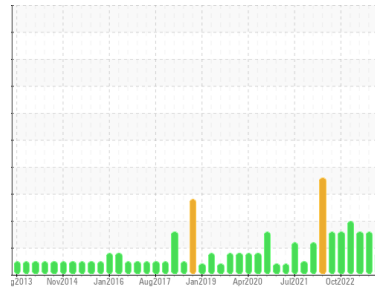
Sample Rating Trend

WEAR

▲ Ferrous Alloys

Sample Status				ATTENTION	ABNORMAL	ABNORMAL
Iron	ppm	ASTM D5185(m)	>7	▲ 7	▲ 9	▲ 8

Resample at the next service interval to monitor.

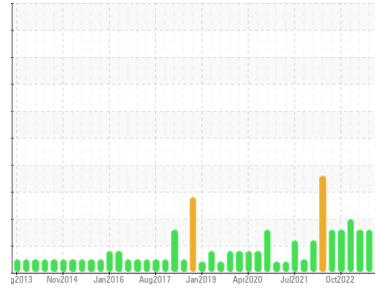
Sample Rating Trend

Wear
 Iron ppm levels are noted. All other component wear rates are normal.

Contamination
 The system cleanliness is acceptable for your target ISO 4406 cleanliness code. The system and fluid cleanliness is acceptable.

Fluid Condition
 The AN level is acceptable for this fluid. The condition of the oil is suitable for further service.

Recommendation
 Resample at the next service interval to monitor.

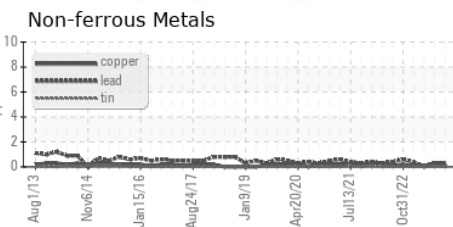
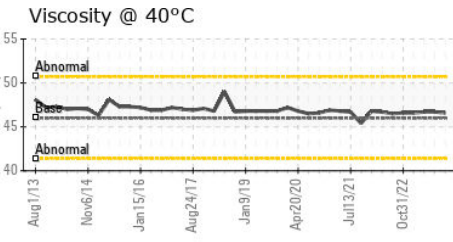
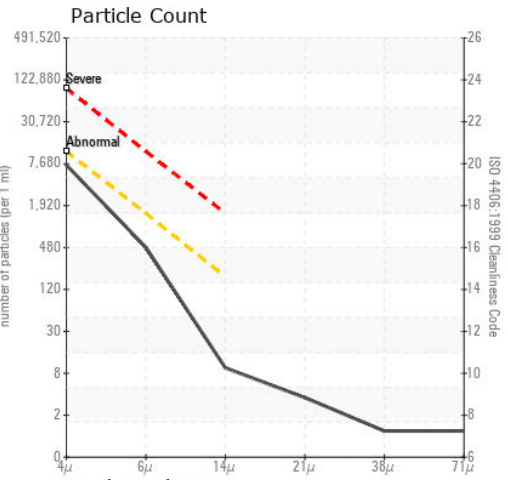
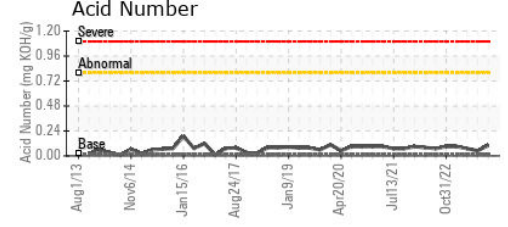
GRAPHS

method	limit/base	current	history1	history2
Iron	ppm	ASTM D5185(m) >7	▲ 7	▲ 9	▲ 8
Chromium	ppm	ASTM D5185(m) >2	0	0	0
Nickel	ppm	ASTM D5185(m) >2	0	0	0
Titanium	ppm	ASTM D5185(m)	0	0	0
Silver	ppm	ASTM D5185(m)	<1	0	0
Aluminum	ppm	ASTM D5185(m) >2	<1	0	<1
Lead	ppm	ASTM D5185(m) >33	<1	<1	0
Copper	ppm	ASTM D5185(m) >3	<1	<1	<1
Tin	ppm	ASTM D5185(m) >6	0	0	0
Antimony	ppm	ASTM D5185(m)	0	0	0
Vanadium	ppm	ASTM D5185(m)	0	0	0
Beryllium	ppm	ASTM D5185(m)	0	0	0
Cadmium	ppm	ASTM D5185(m)	0	0	0

method	limit/base	current	history1	history2
Particles >4µm	ASTM D7647	>10000	6402	▲ 20083	▲ 22585
Particles >6µm	ASTM D7647	>1300	423	1171	797
Particles >14µm	ASTM D7647	>160	8	14	8
Particles >21µm	ASTM D7647	>40	3	2	3
Particles >38µm	ASTM D7647	>10	1	0	1
Particles >71µm	ASTM D7647	>3	1	0	0
Oil Cleanliness	ISO 4406 (c)	>20/17/14	20/16/10	▲ 22/17/11	▲ 22/17/10
