PROBLEM SUMMARY

Area
[412827297]
 Machine Id
Viscera Table Upper Gearbox
 Component
Gearbox
 Fluid
KLUBER KLUBEROIL 4 UH1-460 N (--- GAL)

Customer Id: CARGUE
 Sample No.: WC0881695
 Lab Number: 02601064
 Test Package: IND 2

OIL ANALYSIS REPORT

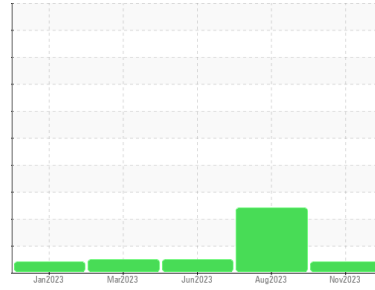
Sample Rating Trend

▲ Viscosity @ 40°C

Sample Status				ABNORMAL	ABNORMAL	NORMAL
Visc @ 40°C	cSt	ASTM D7279(m)	460	▲ 225	420	421

Due to this condition we recommend the following action... We advise an early resample to confirm this situation. NOTE: The current sample results do not match this units historical trend, indicating the sample may not be from this component/unit.

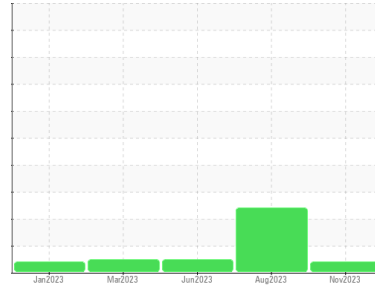
Sample Rating Trend

Viscosity of sample indicates oil is within ISO 220 range, advise investigate. The AN level is acceptable for this fluid. The condition of the oil is suitable for further service.

FLUID PROPERTIES	method	limit/base	current	history1	history2
Visc @ 40°C	cSt	ASTM D7279(m)	460	▲ 225	420

Due to this condition we recommend the following action... We advise an early resample to confirm this situation. NOTE: The current sample results do not match this units historical trend, indicating the sample may not be from this component/unit.
