# OIL ANALYSIS REPORT

Machine Id  
**HEAD STR PRESS #1**

Component  
**Hydraulic System**

Fluid  
**AW HYDRAULIC OIL ISO 46 (116 GAL)**

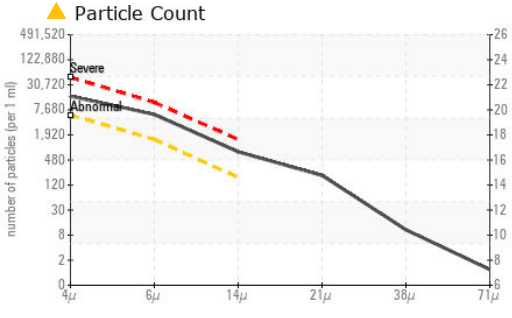
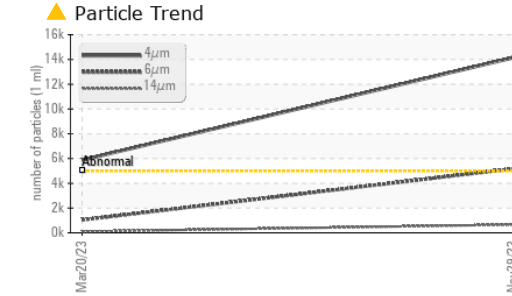
## GRAPHS

Oil Cleanliness are abnormally high. Particles >14µm are abnormally high. Particles >21µm are abnormally high. Particles >4µm are abnormally high. Particles >6µm are abnormally high.

FLUID CLEANLINESS		method	limit/base	current	history1	history2
Particles >4µm	ASTM D7647		>5000	<b>▲ 14137</b>	▲ 5870	---
Particles >6µm	ASTM D7647		>1300	<b>▲ 5176</b>	1039	---
Particles >14µm	ASTM D7647		>160	<b>▲ 661</b>	99	---
Particles >21µm	ASTM D7647		>40	<b>▲ 179</b>	33	---
Particles >38µm	ASTM D7647		>10	<b>9</b>	1	---
Particles >71µm	ASTM D7647		>3	<b>1</b>	0	---
Oil Cleanliness	ISO 4406 (c)		>19/17/14	<b>▲ 21/20/17</b>	▲ 20/17/14	---
