# PROBLEM SUMMARY

Machine Id  
**VACUUM DEGASSER PUMP**  
 Component  
**Hydraulic System**  
 Fluid  
**SHELL TELLUS S2 MX 46 (15000 GAL)**

# OIL ANALYSIS REPORT

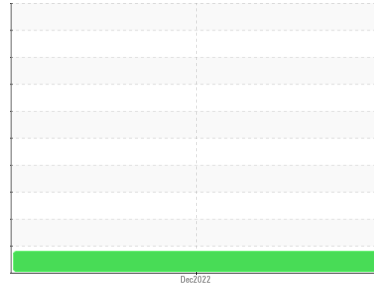
Sample Rating Trend

INSOLUBLES

### ▲ Varnish Potential

Sample Status				<b>SEVERE</b>	---	---
MPC Varnish Potential	Scale	ASTM D7843	>15	▲ 55	---	---

We recommend that you use depth filtration to remove insolubles from the oil and to reduce the levels of varnish in the system. Alternatively draining a percentage of the oil and topping up with fresh oil (sweetening the oil) may provide a reduction in the varnish potential level. We recommend an early resample to monitor this condition. Additional phone discussion regarding this analysis included information that the spot test for varnish on the MPC indicated that not all of the varnish components are purely varnish. Pure varnish will react to the test chemical and this MPC did not react as typical for varnish, suggesting there is a secondary process happening in the lubricant creating solids such as ash or a chemical conversion to another chemical or polymer that is insoluble. This may be a result of mixing lubricant with incompatible additives, or may be a result of a combustion process such as filtration static arcing or microdieseling. Please note that this is a corrected copy of this report to include additional commentary to document phone conversation points.

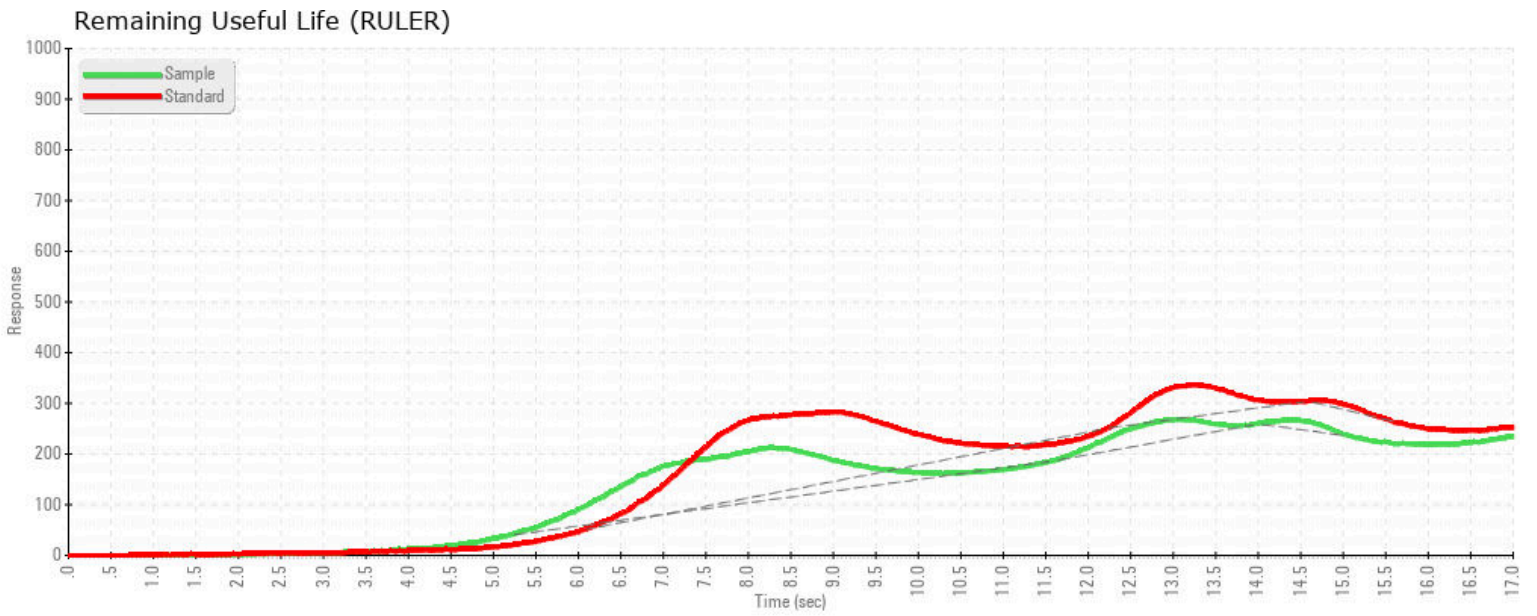
MPC (Varnish Test)

FLUID DEGRADATION		method	limit/base	current	history1	history2
Acid Number (AN)	mg KOH/g	ASTM D8045		<b>0.33</b>	---	---
Anti-Oxidant 1	%	ASTM D6971	<25	<b>69</b>	---	---
Anti-Oxidant 2	%	ASTM D6971	<25	<b>67</b>	---	---
Anti-Oxidant 3	%	ASTM D6971	<25	<b>158</b>	---	---
MPC Varnish Potential	Scale	ASTM D7843	>15	<b>▲ 55</b>	---	---
