PROBLEM SUMMARY

Area
Evp Island
 Machine Id
GOULDS B HSC Pump 0306
 Component
Pump Roller Bearing
 Fluid
MOBIL SHC 626 (1 GAL)

OIL ANALYSIS REPORT

FERROGRAPHY REPORT

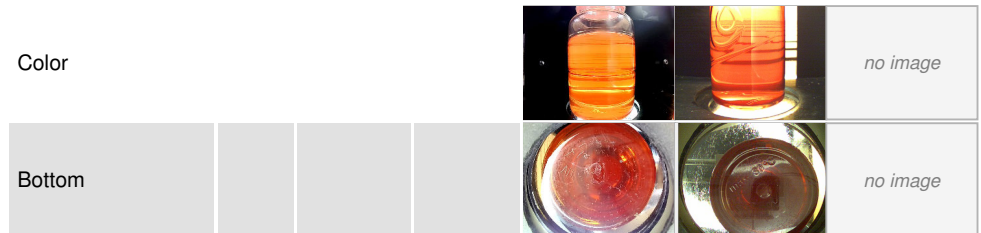
SAMPLE IMAGES	method	limit/base	current	history1	history2
---------------	--------	------------	---------	----------	----------

We recommend you service the filters on this component. Resample at the next service interval to monitor. Analytical Ferrography: Results suggest there is a mild source of red oxide present in this system or in refill lubricant. In the first 3 associated images from the slide, the debris is under a polarized light and any of the orange or reddish debris should be considered to most likely be a red oxide. The volume of oxide debris is not exceptionally high but it is unusual and should be dealt with at the earliest opportunity to ensure this debris does not cause any additional wear. At the moment, all other debris appears to be at a typical size and volume. If the filters for this system are not designed to handle such small debris (the average oxide particle is ~2-3 microns) consider a lubricant polish with traditional low micron filters, depth media filtration, or something similar. Consider investigating the source of contamination and correct it if possible.

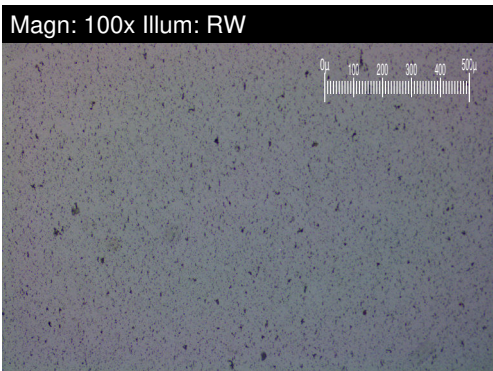
All component wear rates are normal.
 The analytical ferrographic results are normal indicating no abnormal wear in the system.
