PROBLEM SUMMARY

Machine Id
AUTOCANE 1A
Component
Gearbox
Fluid
CHEVRON MEROPA 220 (10 GAL)

OIL ANALYSIS REPORT

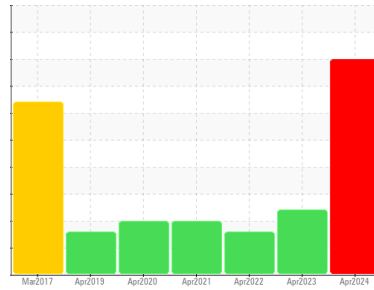
WATER

▲ Water (KF)

Sample Status				SEVERE	ABNORMAL	ABNORMAL
Water	%	ASTM D6304	>0.2	▲ 0.534	0.022	0.036
ppm Water	ppm	ASTM D6304	>2000	▲ 5340	227.0	362.5
Silt	scalar	*Visual	NONE	▲ MODER	NONE	NONE
Emulsified Water	scalar	*Visual	>0.2	▲ 0.2%	NEG	NEG
Free Water	scalar	*Visual		▲ 2.0	NEG	NEG

We advise that you check for the source of water entry. We advise that you follow the water drain-off procedure for this component, and use off-line filtration to improve the cleanliness of the system fluid. We recommend an early resample to monitor this condition. We were unable to perform a particle count due to a high concentration of particles present in this sample. Due to an abnormal test result it is recommended to contact Stauff Corp at (201)-444-7800 for help resolving the issue.

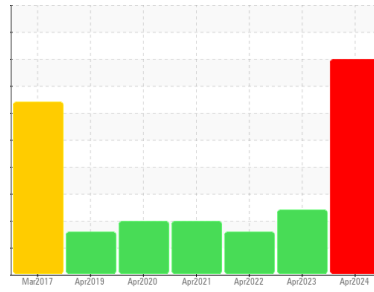
WATER

Appearance is hazy. Free water present. There is a moderate concentration of water present in the oil. There is a moderate amount of visible silt present in the sample.

We advise that you check for the source of water entry. We advise that you follow the water drain-off procedure for this component, and use off-line filtration to improve the cleanliness of the system fluid. We recommend an early resample to monitor this condition. We were unable to perform a particle count due to a high concentration of particles present in this sample. Due to an abnormal test result it is recommended to contact Stauff Corp at (201)-444-7800 for help resolving the issue.
