PROBLEM SUMMARY

Machine Id
TURBINA 09 - FRONT BEARING (S/N 101311)
 Component
Grease
 Fluid
KLUBER KLUBERPLEX BEM 41-141 (--- LTR)

GREASE ANALYSIS

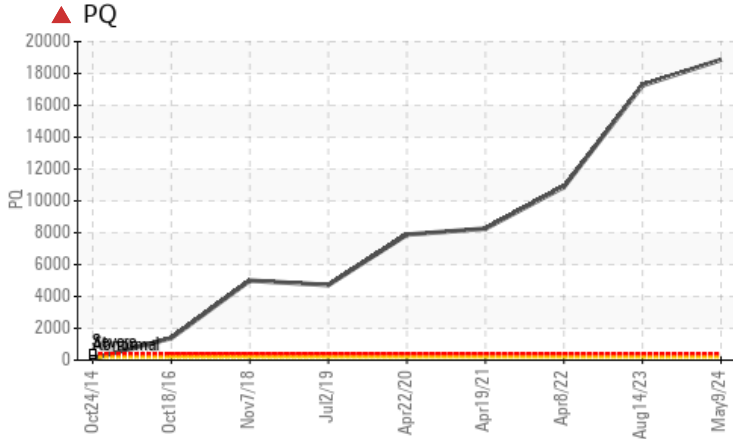
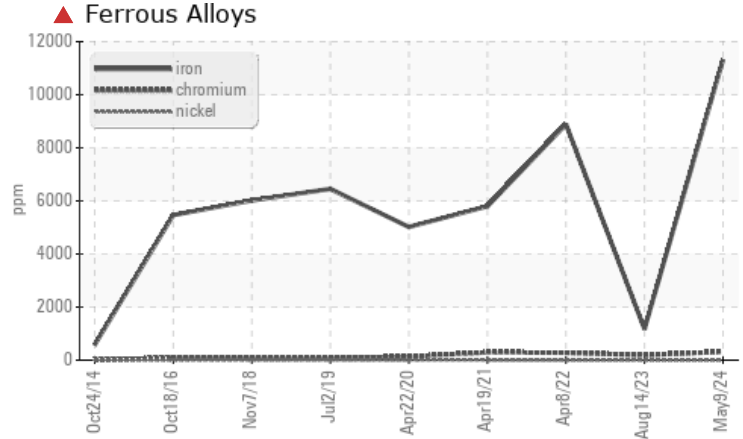
COMPONENT CONDITION SUMMARY

Sample Status			SEVERE	ABNORMAL	SEVERE
PQ		ASTM D8184 >200	▲ 18861	▲ 17256	▲ 10883
Iron	ppm	ASTM D5185m >250	▲ 11320	▲ 1176	▲ 8886
Chromium	ppm	ASTM D5185m >10	▲ 317	▲ 190	▲ 279

An increase in the wear is noted. Bearing and/or bushing wear is indicated.

The grease is no longer serviceable as a result of the abnormal and/or severe wear.

Purge old grease. We recommend an early resample to monitor this condition.

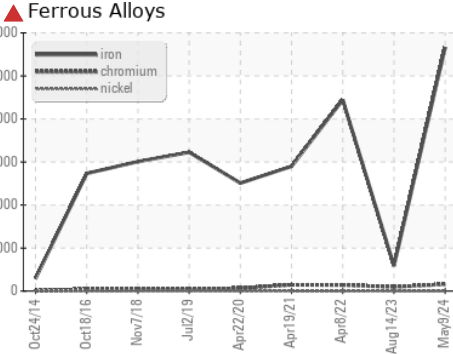
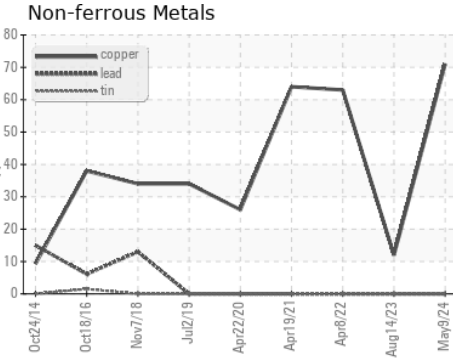
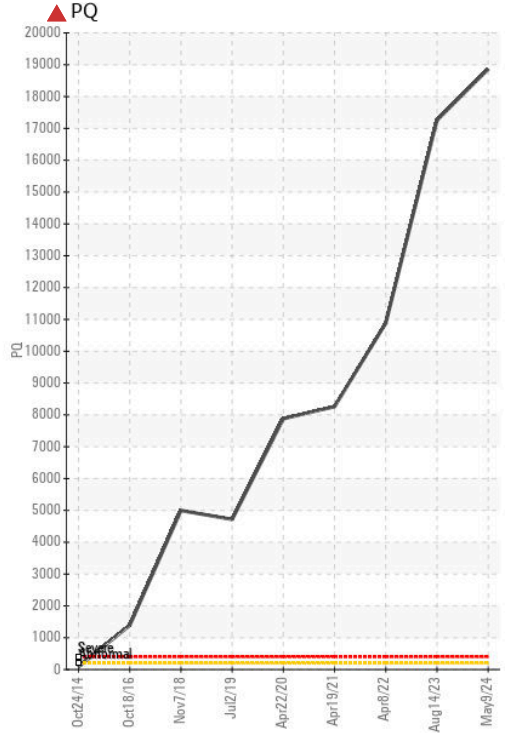
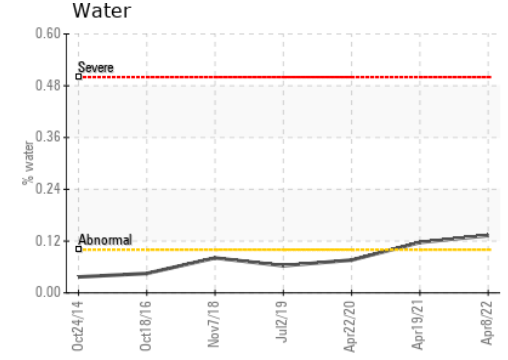
GRAPHS

method	limit/base	current	history1	history2
PQ	ASTM D8184	>200	▲ 18861	▲ 17256	▲ 10883
Iron	ppm	ASTM D5185m	>250	▲ 11320	▲ 1176
Chromium	ppm	ASTM D5185m	>10	▲ 317	▲ 190
Nickel	ppm	ASTM D5185m	>5	0	0
Cadmium	ppm	ASTM D5185m		0	<1
Titanium	ppm	ASTM D5185m		2	<1
Vanadium	ppm	ASTM D5185m		2	<1
Lead	ppm	ASTM D5185m	>25	0	0
Copper	ppm	ASTM D5185m	>75	71	12
Tin	ppm	ASTM D5185m	>5	0	0
Silver	ppm	ASTM D5185m	>5	0	<1
