# OIL ANALYSIS REPORT

**LS-043024-01C-200C**

**Chain**

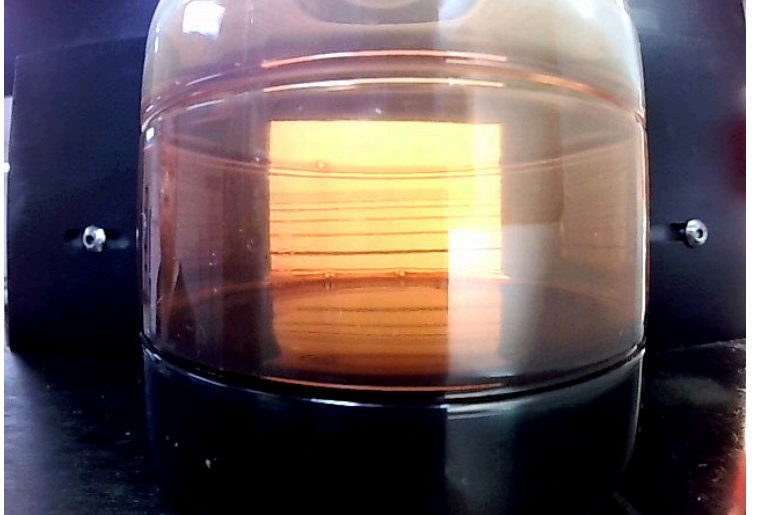
Sample Color & Clarity

MPC (Membrane Patch Colorimetry) test indicates a high concentration of varnish present.

method	limit/base	current	history1	history2
MPC Varnish Potential	Scale	ASTM D7843	>15 <b>▲ 58</b>	---	---

This is a baseline read-out on the submitted sample.
