OIL ANALYSIS REPORT

Area
SHARP BUS LINES
Machine Id
INTERNATIONAL 1218
Component
Diesel Engine
Fluid
DIESEL ENGINE OIL SAE 15W40 (--- GAL)

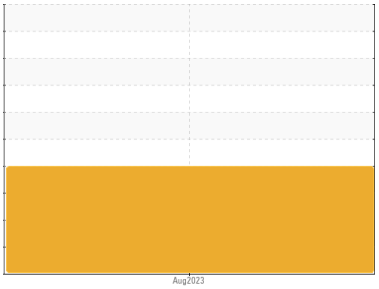
SOOT

There is a high amount of fuel present in the oil. There is an abnormal amount of solids and carbon present in the oil. Tests confirm the presence of fuel in the oil.

The oil is no longer serviceable due to the presence of contaminants.

We advise that you check the fuel injection system. We advise that you check for faulty combustion, plugged air filters, or aftercoolers. The oil change at the time of sampling has been noted. We recommend an early resample to monitor this condition.
