LINE 12

Customer: PTRHTF60002	System Information	Sample Information
BOYNE SMELTERS LTD-RIO TINTO HANDLEY DRIVE QUEENSLAND BOYNE ISLAND, QUE 4680 AUSTRALIA Attn: Simon Spencer Tel: (042)744-6575	System Volume: 0 ltr Bulk Operating Temp: 514F / 268C Heating Source: Blanket: Fluid: PETRO CANADA CALFLO AF Make:	Lab No: 02194231 Analyst: Yutong Gao Sample Date: 01/10/18 Received Date: 01/23/18 Completed: 01/25/18 To discuss this report contact Yutong Gao at (403)873-1876

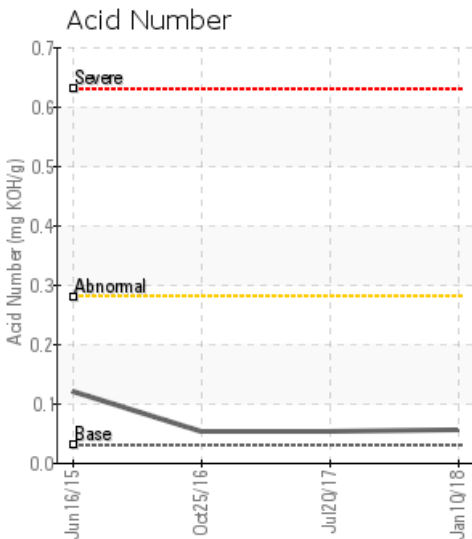
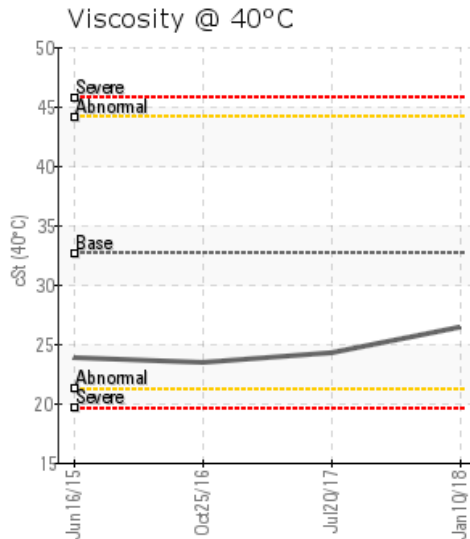
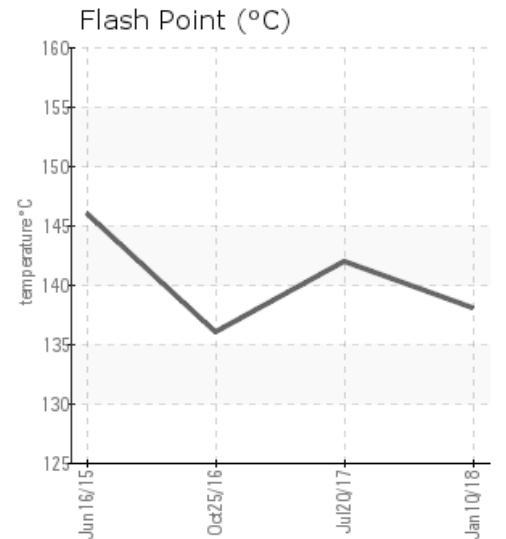
Sample Date	Received Date	Fluid Age	Sample Location	Flash Point (COC)	Water (KF)	Viscosity (40°C)	Acid Number	Solids	GCD 10%	GCD 50%	GCD 90%	GCD % < 335°C
	mm/dd/yy			°F/°C	ppm	cSt	mg/KOH/g	%wt	°F/°C	°F/°C	°F/°C	%
01/10/18	01/23/18	10y		280 / 138	2.0	26.4	0.056	0.031	645 / 341	766 / 408	873 / 467	8.01
07/20/17	09/06/17	20y	NEAR RETURN TO GAS B	288 / 142	30.9	24.2	0.052	0.035	659 / 348	790 / 421	895 / 480	7.03
10/25/16	11/04/16	10y	NEAR RTRN TO GAS BRN	277 / 136	39.4	23.4	0.052	0.054	651 / 344	790 / 421	895 / 479	7.87
06/16/15	07/02/15	15y	LINE 1/2 AFTER PUMPS	295 / 146	25.2	23.9	0.12	0.017	661 / 349	792 / 422	901 / 483	6.70
Baseline Data				435 / 224		32.7	0.03		693 / 367	790 / 421	887 / 475	2.5

Recommendation: The current fluid has the similar conditions as the 2017 and 2016 samples. The fluid has been thermal cracked with some light boiler to reduce the flash point. Please conduct the effective system venting to release the oil vapor, or just do the 30% oil change to bring back the oil flash point and viscosity. Please take one sample in 6 months to monitor.

07/20/17	The fluid has a very similar condition as the sample in 2016. The fluid has normal acid number and solid content. However, the viscosity and flash point are all low because of the thermal cracking at 268C bulk working temperature. The effective system venting is required as soon as possible to release the light oil vapor. Please take one sample in one year to monitor the conditions.
10/25/16	The fluid flash point is severely low and the viscosity is abnormally low. The current fluid has a lot of low boiler (light end) due to the thermal cracking. The solid content, water ppm and TAN number are all normal. Please conduct the effective venting process as soon as possible to release the light end/oil vapor from the system. System venting is a recommended regular maintenance practice for any closed heat transfer system. If there is no way to vent the light end, please consider the complete fluid change or at least partial (i.e. 1/3 of the fluid) change to bring back the flash point and viscosity. Take one sample to verify the improvement after a longer and effective venting process or a partial fluid change.
