Customer Id: EXTWOO
Sample No.: PC0062180
Lab Number: 02600531
Test Package: IND 2

OIL ANALYSIS REPORT

Machine Id
PRESS #5 (S/N MPR-49611)
Component
Hydraulic System
Fluid
PETRO CANADA HYDREX AW 68 (4000 GAL)

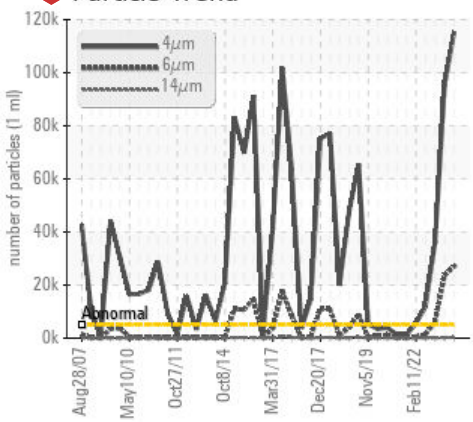
Particle Trend

There is a high amount of silt (particulates < 14 microns in size) present in the oil.

Check seals and/or filters for points of contaminant entry. The air breather requires service. If unrated, we recommend that you replace with a suitable micron rated and/or desiccant air breather. If rated, we recommend that you service/replace the breather. We recommend you service the filters on this component. Resample in 30-45 days to monitor this situation. Please contact your representative for information regarding the proper sampling kits for your service. NOTE: We recommend using Advanced Oil Monitoring (AOM) kits for this system. The AOM test package includes advanced level testing to determine the suitability of turbine and large industrial compressor oils for continued use.

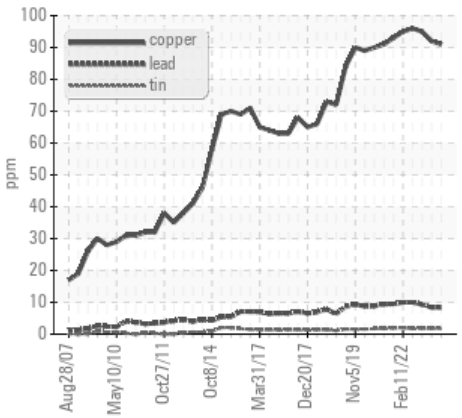
Non-ferrous Metals

Copper ppm levels are noted. All other component wear rates are normal.

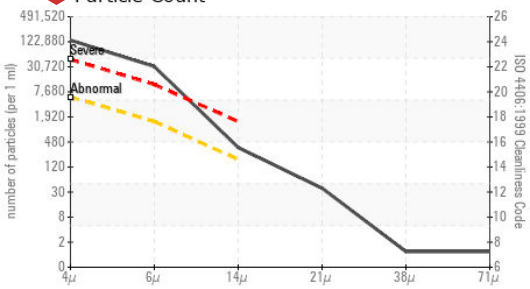
Particle Count

FLUID CLEANLINESS	method	limit/base	current	history1	history2
Particles >4µm	ASTM D7647	>5000	**115408**	95394	36251
Particles >6µm	ASTM D7647	>1300	**27014**	23627	5993
Particles >14µm	ASTM D7647	>160	**311**	187	115
Particles >21µm	ASTM D7647	>40	**33**	14	17
Particles >38µm	ASTM D7647	>10	**1**	1	2
Particles >71µm	ASTM D7647	>3	**1**	1	1
Oil Cleanliness	ISO 4406 (c)	>19/17/14	**24/22/15**	24/22/15	22/20/14

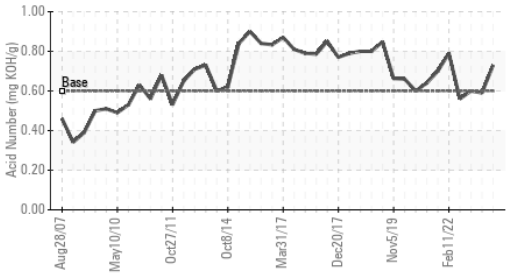
The AN level is acceptable for this fluid. The condition of the oil is acceptable for the time in service (unconfirmed). The oil is still serviceable provided that the contaminant(s) can be reduced to acceptable levels.

FLUID DEGRADATION		method	limit/base	current	history1	history2
Acid Number (AN)	mg KOH/g	ASTM D974*	0.60	**0.73**	0.59	0.60
