SUPPLY CARGILL MEAT THAILAND

Customer: PTRHTF60010	System Information	Sample Information
SYNLUBE INTERNATIONAL CO LTD 76/1 MOO.7 THACHIN MUANG SAMUTSAKHON, 74000 THAILAND Attn: CHERNPORN CHOBKUI Tel: 034421290 E-Mail: chernporn@synlube.co.th	System Volume: 20910 ltr Bulk Operating Temp: 554F / 290C Heating Source: Blanket: Fluid: PETRO CANADA PURITY FG HEAT TRANSFER FLUID Make: WANSON	Lab No: 02227970 Analyst: Yutong Gao Sample Date: 06/28/18 Received Date: 07/13/18 Completed: 08/23/18 To discuss this report contact Yutong Gao at (403)873-1876

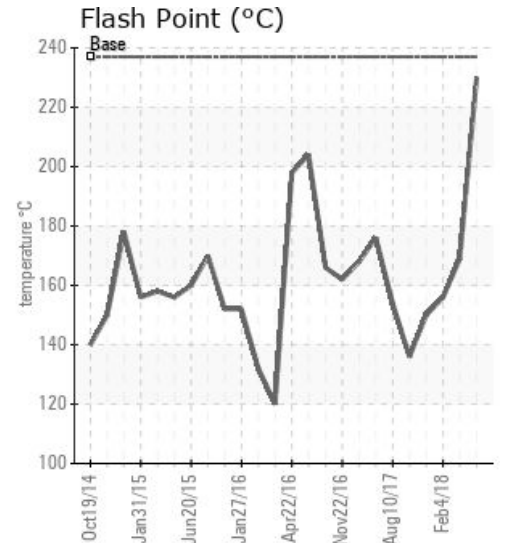
Sample Date	Received Date	Fluid Age	Sample Location	Flash Point (COC)	Water (KF)	Viscosity (40°C)	Acid Number	Solids	GCD 10%	GCD 50%	GCD 90%	GCD % < 335°C
	mm/dd/yy			°F/°C	ppm	cSt	mg/KOH/g	%wt	°F/°C	°F/°C	°F/°C	%
06/28/18	07/13/18	0m	SUPPLY	446 / 230	0.00	36.0	0.51	0.009	724 / 385	789 / 420	868 / 464	0.00
05/23/18	06/12/18	25m		336 / 169	12.7	30.3	0.17	0.048	677 / 359	781 / 416	873 / 467	4.51
02/04/18	02/26/18	22m		313 / 156	0.00	27.7	0.276	0.036	665 / 352	769 / 409	890 / 477	4.38
11/01/17	11/14/17	19m		302 / 150	10.7	26.9	0.13	0.031	674 / 357	805 / 430	897 / 481	6.43
10/13/17	10/24/17	19m	SUPPLY	277 / 136	0.1	26.8	0.252	0.015	668 / 353	798 / 426	892 / 478	6.82
08/10/17	08/22/17	17m		309 / 154	9.9	22.0	0.19	0.040	675 / 357	799 / 426	895 / 480	6.22
Baseline Data				459 / 237		37.12	0.90		721 / 383	807 / 431	892 / 478	1.5

Recommendation: The current fluid has normal viscosity, flash point, solid and GCD distillation. It is suitable for further use. Need to confirm if the fluid has been changed recently? The flash point has been improved a lot by comparing with the last sample in May 2018. Please take one sample in 6 months to monitor the conditions.
