OIL DIAGNOSTICS

Area
[98405827]
Machine Id
KR-GR-002491 - INCLINE AUGER 8A (S/N GRIND A - 11513018)
Component
Gearbox
Fluid
PETRO CANADA 220 (17 QTS)

OIL ANALYSIS REPORT

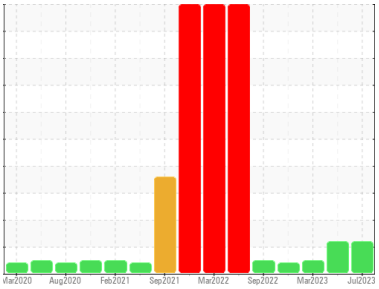
Sample Rating Trend

Sample Status				ABNORMAL	ABNORMAL	NORMAL
Particles >4µm		ASTM D7647	>10000	▲ **97805**	▲ 91767	---
Particles >6µm		ASTM D7647	>2500	▲ **15009**	▲ 16119	---
Oil Cleanliness		ISO 4406 (c)	>20/18/16	▲ **24/21/15**	▲ 24/21/16	---

We recommend you service the filters on this component if applicable. Resample at the next service interval to monitor.

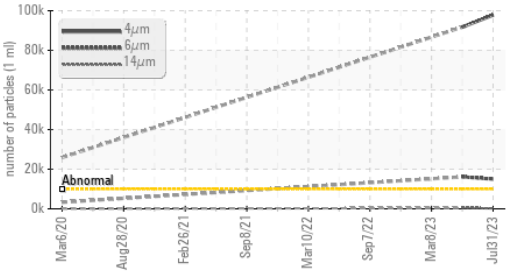
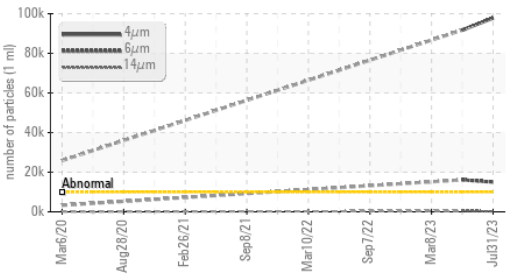
Particle Trend

Contamination
There is a high amount of silt (particulates < 14 microns in size) present in the oil.

FLUID CLEANLINESS		method	limit/base	current	history1	history2
Particles >4µm		ASTM D7647	>10000	▲ **97805**	▲ 91767	---
Particles >6µm		ASTM D7647	>2500	▲ **15009**	▲ 16119	---
Particles >14µm		ASTM D7647	>640	**234**	398	---
Particles >21µm		ASTM D7647	>160	**28**	67	---
Particles >38µm		ASTM D7647	>40	**1**	2	---
Particles >71µm		ASTM D7647	>10	**1**	0	---
Oil Cleanliness		ISO 4406 (c)	>20/18/16	▲ **24/21/15**	▲ 24/21/16	---

Recommendation
We recommend you service the filters on this component if applicable. Resample at the next service interval to monitor.

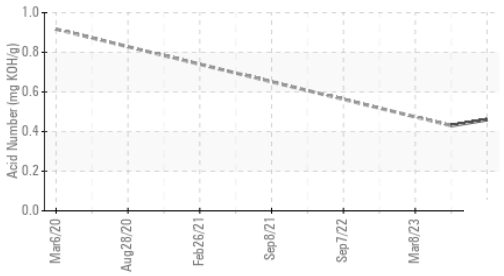
Fluid Condition
The AN level is acceptable for this fluid. The condition of the oil is suitable for further service.

FLUID DEGRADATION		method	limit/base	current	history1	history2
Acid Number (AN)	mg KOH/g	ASTM D8045		**0.46**	0.43	---

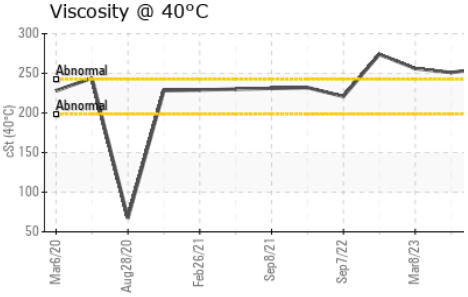
Viscosity @ 40°C

FLUID PROPERTIES		method	limit/base	current	history1	history2
Visc @ 40°C	cSt	ASTM D445		**257**	251	256
