SOUTH HEATER

Customer: PTRHTF10043	System Information	Sample Information
MALARKY ROOFING PRODUCTS 3131 N. COLUMBIA BLVD PORTLAND, OR 97217 USA Attn: SCOTT MCDANIEL Tel: (503)283-1191 E-Mail: smcdaniel@malarkeyroofing.com	System Volume: 1200 gal Bulk Operating Temp: 620F / 327C Heating Source: Blanket: Fluid: PETRO CANADA CALFLO HTF Make: AMERICAN HEATING	Lab No: 02232581 Analyst: Ron LeBlanc Sample Date: 07/26/18 Received Date: 08/08/18 Completed: 08/10/18 To discuss this report contact Ron LeBlanc at (541)678-7044

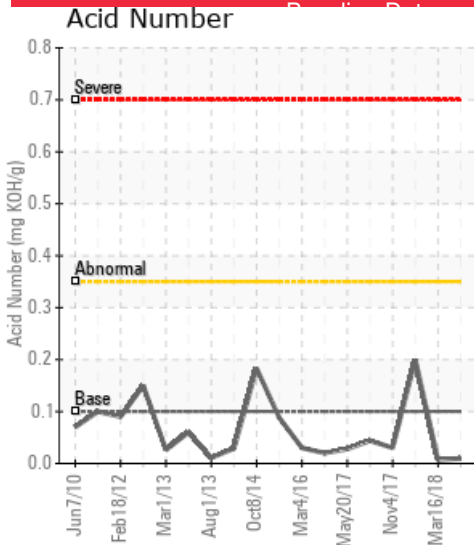
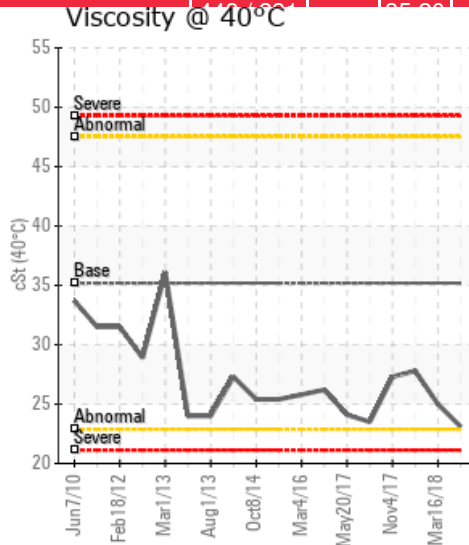
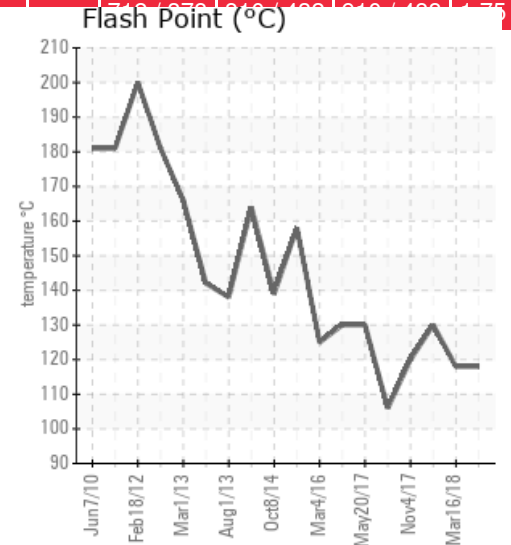
Sample Date	Received Date	Fluid Age	Sample Location	Flash Point (COC)	Water (KF)	Viscosity (40°C)	Acid Number	Solids	GCD 10%	GCD 50%	GCD 90%	GCD % < 335°C
	mm/dd/yy			°F/°C	ppm	cSt	mg/KOH/g	%wt	°F/°C	°F/°C	°F/°C	%
07/26/18	08/08/18	0m	NORTH HEAT EXCHANGE	244 / 118	4.9	23.1	0.01	0.098	662 / 350	775 / 413	865 / 463	6.76
03/16/18	04/02/18	0m		244 / 118	7.3	25.0	0.007	0.031	660 / 349	803 / 428	917 / 491	7.96
01/12/18	01/26/18	0m		266 / 130	0.00	27.8	0.2	0.018	671 / 355	797 / 425	906 / 486	6.64
11/04/17	11/22/17	0m		248 / 120	9.1	27.3	0.03	0.031	632 / 333	796 / 424	893 / 478	9.74
10/04/17	10/17/17	0m		223 / 106	15.1	23.5	0.044	0.036	652 / 344	798 / 426	911 / 488	8.37
05/20/17	06/05/17	0m	NORTH HEAT EXCHANGER	266 / 130	29.5	24.1	0.028	0.061	666 / 352	802 / 428	915 / 490	7.16
09/22/16	10/04/16	0m	NORTH HEAT EXCHANGER	266 / 130	11.2	26.2	0.02	0.040	625 / 330	785 / 419	886 / 475	10.14

Recommendation: Viscosity has dropped from ISO 32 to ISO 22. COC flash point has lowered significantly to a point that should be corrected. Determine what is affecting viscosity. Has there been a heater issue of late causing oil to overheat severely. New oil might need to be added to bring COC flash point up if no other issue is found.

Comments: (GCD) 90% Distillation Point is severely low. COC Flash Point is severely low.
