Customer Id: GFL837
Sample No.: GFL0102460
Lab Number: 06061769
Test Package: FLEET

OIL ANALYSIS REPORT

Machine Id
920096-260369
Component
Diesel Engine
Fluid
CASTROL CRB Multi 15W-40 CK-4 (--- GAL)

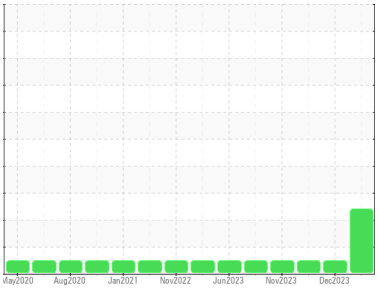
Sample Rating Trend

FUEL

Sample Status				SEVERE	NORMAL	NORMAL
Fuel	%	ASTM D3524	>5	**8.4**	<1.0	<1.0
Visc @ 100°C	cSt	ASTM D445	15.5	**11.5**	13.1	14.0

We advise that you check the fuel injection system. The oil change at the time of sampling has been noted. We recommend an early resample to monitor this condition.

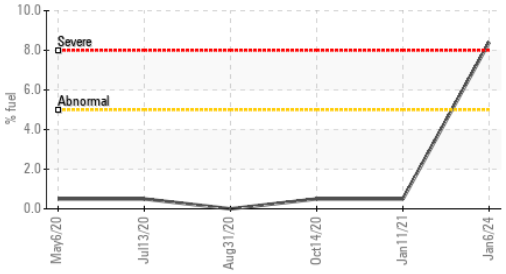
Fuel Dilution

Contamination
There is a high amount of fuel present in the oil. Tests confirm the presence of fuel in the oil.

CONTAMINANTS		method	limit/base	current	history1	history2
Silicon	ppm	ASTM D5185m	>25	**3**	4	2
Sodium	ppm	ASTM D5185m		**3**	4	0
Potassium	ppm	ASTM D5185m	>20	**<1**	<1	4
Fuel	%	ASTM D3524	>5	**8.4**	<1.0	<1.0

Recommendation
We advise that you check the fuel injection system. The oil change at the time of sampling has been noted. We recommend an early resample to monitor this condition.

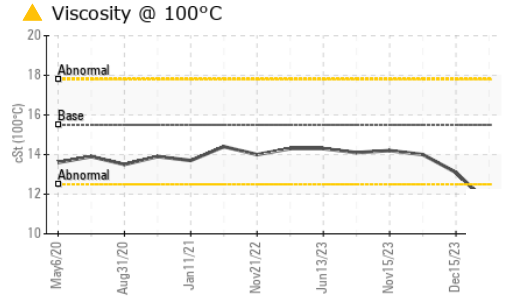
Viscosity @ 100°C

Fluid Condition
The BN result indicates that there is suitable alkalinity remaining in the oil. Fuel is present in the oil and is lowering the viscosity. The oil is no longer serviceable due to the presence of contaminants.

FLUID PROPERTIES		method	limit/base	current	history1	history2
Visc @ 100°C	cSt	ASTM D445	15.5	▲ **11.5**	13.1	14.0

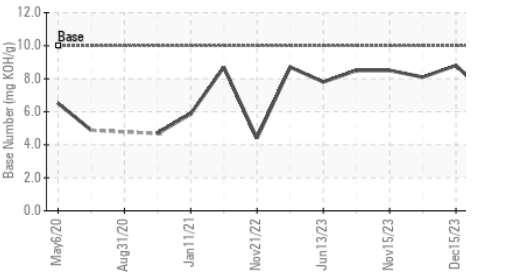
FLUID DEGRADATION		method	limit/base	current	history1	history2
Oxidation	Abs/.1mm	*ASTM D7414	>25	**15.8**	13.4	14.4
Base Number (BN)	mg KOH/g	ASTM D2896	10	**7.0**	8.8	8.1
