[13-25-80-16-W6M] TRAIN #1 HEAT MEDIUM

Customer: PTRHTF20156	System Information	Sample Information
TOURMALINE OIL 13-25-80-16W6 9920 98a Ave FORT ST. JOHN, BC V1J 1S2 Canada Attn: Brandon Braun Tel: (250)262-5420 E-Mail:	System Volume: 40000 ltr Bulk Operating Temp: 383F / 195C Heating Source: Blanket: Fluid: PETRO CANADA PETRO-THERM Make: PROPAK	Lab No: 02237096 Analyst: Clinton Buhler Sample Date: 08/12/18 Received Date: 08/31/18 Completed: 09/06/18 To discuss this report contact Clinton Buhler at 780-516-9920

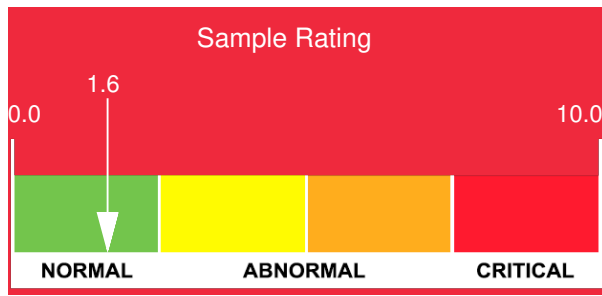
Sample Date	Iron	Chromium	Nickel	Aluminum	Copper	Lead	Tin	Cadmium	Silver	Vanadium	Silicon	Sodium	Potassium	Titanium	Molybdenum	Antimony	Manganese	Lithium	Boron	Magnesium	Calcium	Barium	Phosphorus	Zinc
08/12/18	0	0	0	0	0	0	0	0	0	0	0	0	0	0	0	0	0	0	0	0	0	0	4	0
07/12/18	0	0	0	0	0	0	0	0	0	0	0	0	0	0	0	0	0	0	0	0	0	0	2	0
06/18/18	2	0	0	0	0	0	0	0	0	0	0	1	0	0	0	0	0	0	0	0	1	0	3	0
03/28/18	0	0	0	0	0	0	1	0	0	0	1	0	0	0	0	0	0	0	0	0	0	0	3	0
11/21/16	6	0	0	0	0	0	1	0	0	0	1	0	0	0	0	0	0	1	1	0	0	0	0	1
07/04/16	0	0	0	0	0	0	1	0	0	0	1	0	0	0	0	0	0	0	0	0	0	0	3	0
Baseline Data			0	0						0			0	0					0				0

Elemental analysis results (above) in parts per million (ppm). [10,000 ppm = 1.0%]
