## FREMONT RPG

Customer: PTRHTF10036	System Information	Sample Information
CERTAINTEED - SAINT GOBAIN 6400 STEVENSON BLVD FREMONT, CA 94538-2468 USA Attn: Dan Arata Tel: (510)490-0890 E-Mail: dan.d.arata@saint-gobain.com	System Volume: 5000 gal Bulk Operating Temp: 450F / 232C Heating Source: Blanket: Fluid: PETRO CANADA CALFLO HTF Make: FIRST THERMAL	Lab No: 02237099 Analyst: Steven Slanker Sample Date: 08/22/18 Received Date: 08/31/18 Completed: 09/04/18 To discuss this report contact Steven Slanker at (951)225-2115

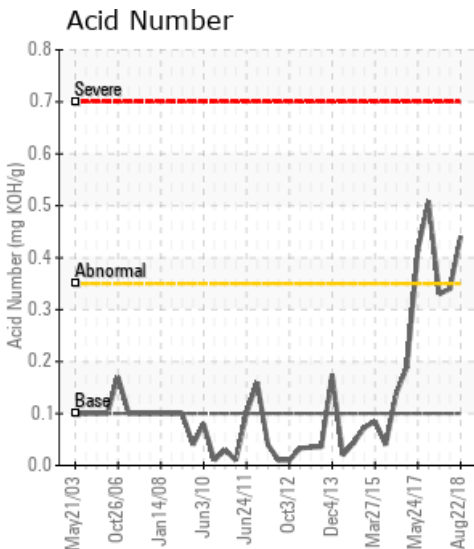
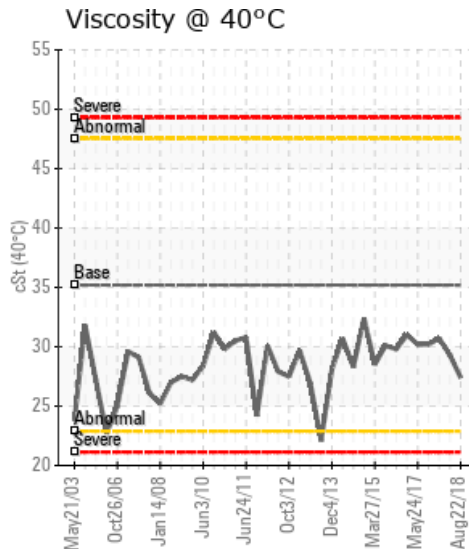
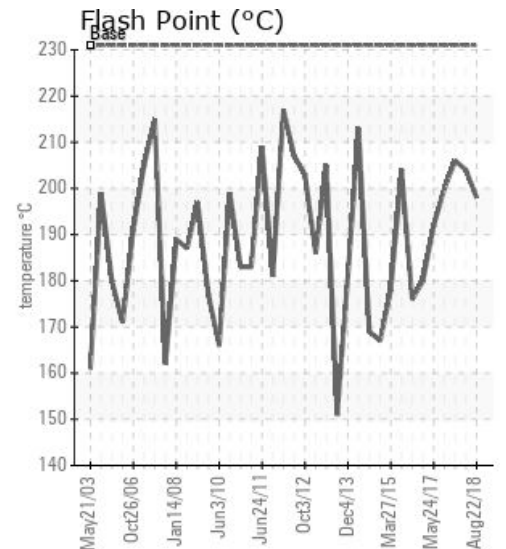
Sample Date	Received Date	Fluid Age	Sample Location	Flash Point (COC)	Water (KF)	Viscosity (40°C)	Acid Number	Solids	GCD 10%	GCD 50%	GCD 90%	GCD % < 335°C
	mm/dd/yy			°F/°C	ppm	cSt	mg/KOH/g	%wt	°F/°C	°F/°C	°F/°C	%
08/22/18	08/31/18	6y	MAIN SUPPLY	388 / 198	9.1	27.4	0.441	0.083	699 / 371	795 / 424	905 / 485	0.70
02/21/18	03/02/18	0y		399 / 204	5.6	29.3	0.34	0.030	688 / 365	781 / 416	869 / 465	2.08
09/22/17	10/11/17	0y		403 / 206	11.1	30.7	0.33	0.075	697 / 369	806 / 430	912 / 489	3.06
08/17/17	08/30/17	4y	MAIN SUPPLY HTR AFTR	392 / 200	21.3	30.2	0.509	0.052	687 / 364	802 / 428	911 / 488	4.24
05/24/17	06/05/17	0y	VALVE BY DAY TANK	378 / 192	31.4	30.2	0.415	0.042	688 / 364	806 / 430	922 / 495	4.25
04/10/17	04/21/17	10y	VALVE PORT WALL SIDE	356 / 180	2.5	31.0	0.19	0.100	688 / 365	815 / 435	940 / 504	4.51
Baseline Data				448 / 231		35.20	.1		712 / 378	810 / 432	910 / 488	1.75

Comments: Flash Point is low and acid number high. Recommend venting to reduce low boilers thereby reducing the low flash point issues. Replace 50% of the fluid to bring the acid number down. Check the pumping system to insure the flow is high enough to minimize thermal cracking in the heater. Thermal cracking generates low boilers and reduces the flash point of the fluid. It also generates high boilers that obstruct downstream piping and elbows. Check the nitrogen blank to insure it is working. By minimizing the presence of oxygen will greatly reduce the oxidation process thereby extending fluid life.
