OIL ANALYSIS REPORT

Machine Id
BLENDER 2
Component
Gearbox
Fluid
MOBIL SHC 630 (15 GAL)

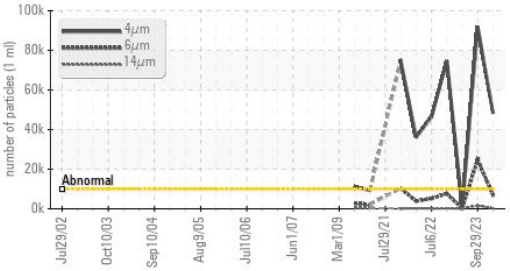
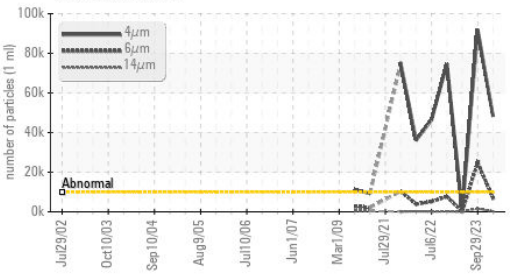
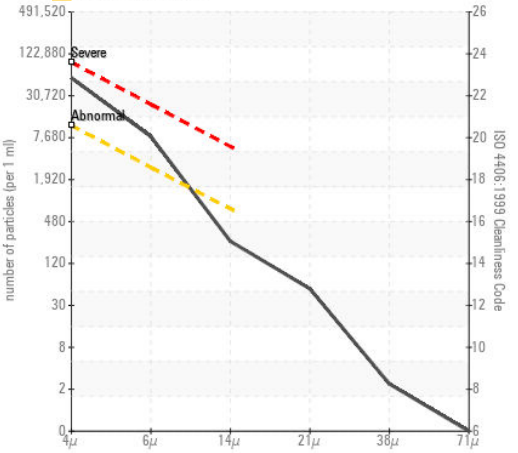
Contamination
There is a high amount of silt (particulates < 14 microns in size) present in the oil.

FLUID CLEANLINESS		method	limit/base	current	history1	history2
Particles >4µm		ASTM D7647	>10000	▲ **48139**	▲ 91910	556
Particles >6µm		ASTM D7647	>2500	▲ **6941**	▲ 24753	63
Particles >14µm		ASTM D7647	>640	**220**	▲ 1633	6
Particles >21µm		ASTM D7647	>160	**46**	▲ 394	1
Particles >38µm		ASTM D7647	>40	**2**	14	0
Particles >71µm		ASTM D7647	>10	**0**	3	0
Oil Cleanliness		ISO 4406 (c)	>20/18/16	▲ **23/20/15**	▲ 24/22/18	16/13/10

Recommendation
We recommend you service the filters on this component if applicable. Resample at the next service interval to monitor.
