FREMONT RPG

Customer: PTRHTF10036	System Information	Sample Information
CERTAINTEED - SAINT GOBAIN 6400 STEVENSON BLVD FREMONT, CA 94538-2468 USA Attn: Dan Arata Tel: (510)490-0890 E-Mail: dan.d.arata@saint-gobain.com	System Volume: 5000 gal Bulk Operating Temp: 450F / 232C Heating Source: Blanket: Fluid: PETRO CANADA CALFLO HTF Make: FIRST THERMAL	Lab No: 02242295 Analyst: Gaston Arseneault Sample Date: 09/19/18 Received Date: 10/01/18 Completed: 10/02/18 To discuss this report contact Gaston Arseneault at 973-986-6503

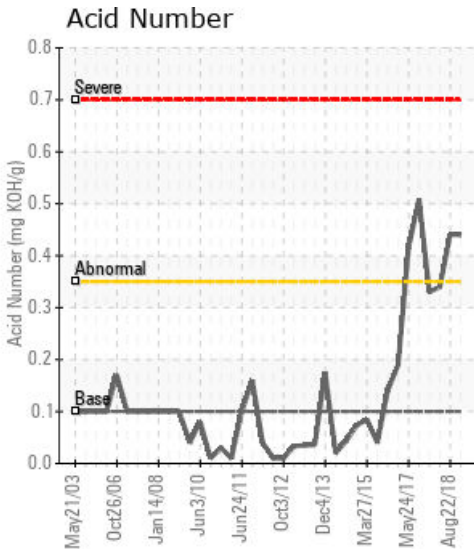
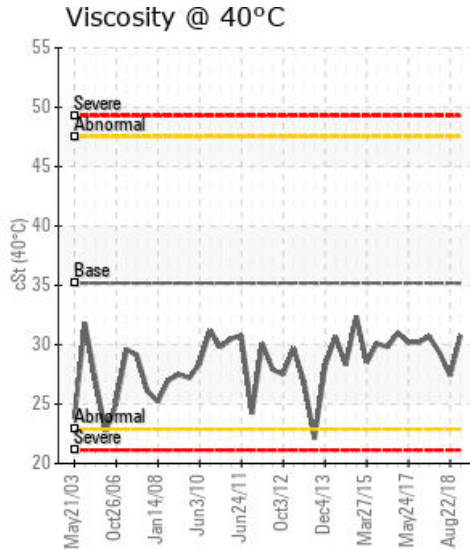
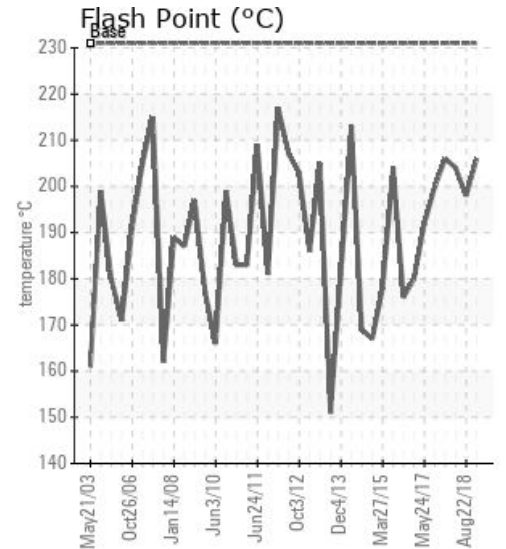
Sample Date	Received Date	Fluid Age	Sample Location	Flash Point (COC)	Water (KF)	Viscosity (40°C)	Acid Number	Solids	GCD 10%	GCD 50%	GCD 90%	GCD % < 335°C
	mm/dd/yy			°F/°C	ppm	cSt	mg/KOH/g	%wt	°F/°C	°F/°C	°F/°C	%
09/19/18	10/01/18	6y		403 / 206	2.7	30.8	0.44	0.048	700 / 371	790 / 421	878 / 470	0.52
08/22/18	08/31/18	6y	MAIN SUPPLY	388 / 198	9.1	27.4	0.441	0.083	699 / 371	795 / 424	905 / 485	0.70
02/21/18	03/02/18	0y		399 / 204	5.6	29.3	0.34	0.030	688 / 365	781 / 416	869 / 465	2.08
09/22/17	10/11/17	0y		403 / 206	11.1	30.7	0.33	0.075	697 / 369	806 / 430	912 / 489	3.06
08/17/17	08/30/17	4y	MAIN SUPPLY HTR AFTR	392 / 200	21.3	30.2	0.509	0.052	687 / 364	802 / 428	911 / 488	4.24
05/24/17	06/05/17	0y	VALVE BY DAY TANK	378 / 192	31.4	30.2	0.415	0.042	688 / 364	806 / 430	922 / 495	4.25
Baseline Data				448 / 231		35.20	.1		712 / 378	810 / 432	910 / 488	1.75

Recommendation: The Acid Number remains high at 0.44. It was always a bit elevated but it might be best to dilute these degradation products by replacing a part of the fluid with fresh oil, so that this fluid charge can be run for many more years. Replacing 20% will bring down the Acid Number to below 0.4 which is sort of our initial warning limit. Moreover, we suggest to look into the possible causes of the high Acid Number and oil oxidation. Make sure the nitrogen blanket works and that the fluid is not allowed to boil off for days on end because that's when the hot oil gets in contact with air and accelerates its oxidation.

Comments: Acid Number (AN) is abnormally high. (GCD) 90% Distillation Point is abnormally low.
