Area
1
Machine Id
1-201-2
Component
Air Compressor
Fluid
GARDNER DENVER AEON 4000 (150 LTR)

Customer Id: STMBOW
Sample No.: WC0818114
Lab Number: 02560207
Test Package: IND 2

OIL ANALYSIS REPORT

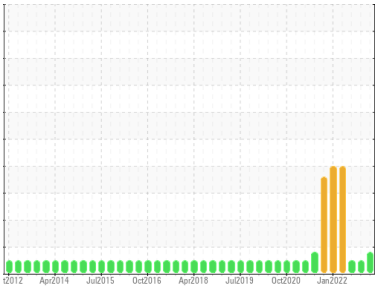
Sample Rating Trend

VISCOSITY

Sample Status				**ABNORMAL**	NORMAL	NORMAL
Sulfur	ppm	ASTM D5185(m)	1629	▲ **308**	1087	1532
Visc @ 40°C	cSt	ASTM D7279(m)	46.8	▲ **58.2**	53.0	52.2

Confirm the source of the lubricant being utilized for top-up/fill. Resample at the next service interval to monitor.

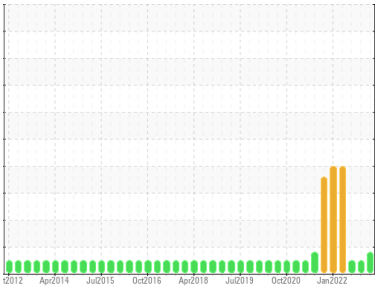
Sample Rating Trend

VISCOSITY

Fluid Condition
Viscosity of sample indicates oil is within ISO 68 range, advise investigate. This plus the additive levels indicates that this is not the same brand, or type of oil as reported. The AN level is acceptable for this fluid. The condition of the oil is suitable for further service.

Recommendation
Confirm the source of the lubricant being utilized for top-up/fill. Resample at the next service interval to monitor.
