OIL ANALYSIS REPORT

Area
[61082]
Machine Id
VOLVO VNL 4440
Component
Diesel Engine
Fluid
PETRO CANADA DURON SAE 10W30 (--- GAL)

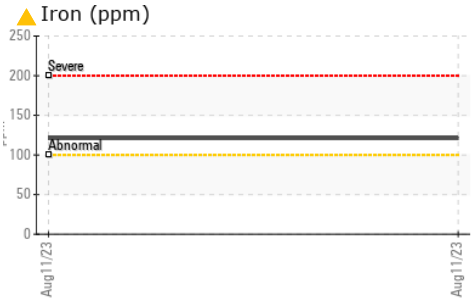
Iron (ppm)

Wear
Iron ppm levels are abnormal. Cylinder, crank, or cam shaft wear is indicated.

Fluid Condition
The oil is no longer serviceable as a result of the abnormal and/or severe wear.

WEAR METALS		method	limit/base	current	history1	history2
PQ		ASTM D8184*		**0**	---	---
Iron	ppm	ASTM D5185(m)	>100	▲ **121**	---	---
Chromium	ppm	ASTM D5185(m)	>20	**2**	---	---
Nickel	ppm	ASTM D5185(m)	>2	**2**	---	---
Titanium	ppm	ASTM D5185(m)		**<1**	---	---
Silver	ppm	ASTM D5185(m)	>2	**<1**	---	---
Aluminum	ppm	ASTM D5185(m)	>25	**15**	---	---
Lead	ppm	ASTM D5185(m)	>40	**2**	---	---
Copper	ppm	ASTM D5185(m)	>330	**14**	---	---
Tin	ppm	ASTM D5185(m)	>15	**1**	---	---
Antimony	ppm	ASTM D5185(m)		**0**	---	---
Vanadium	ppm	ASTM D5185(m)		**0**	---	---
Beryllium	ppm	ASTM D5185(m)		**0**	---	---
Cadmium	ppm	ASTM D5185(m)		**0**	---	---

Recommendation
We recommend that you drain the oil from the component if this has not already been done. We recommend an early resample to monitor this condition.
