# **UNIT B**

### System Information

Fluid: PETRO CANADA CALFLO HTF

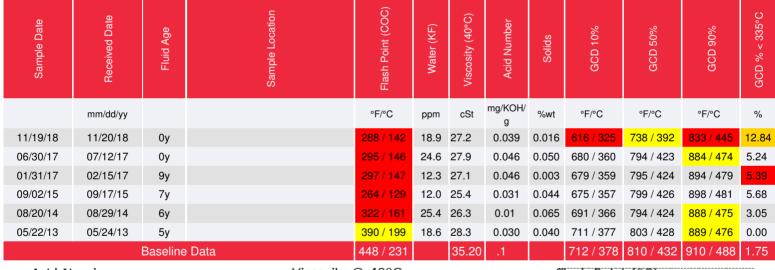
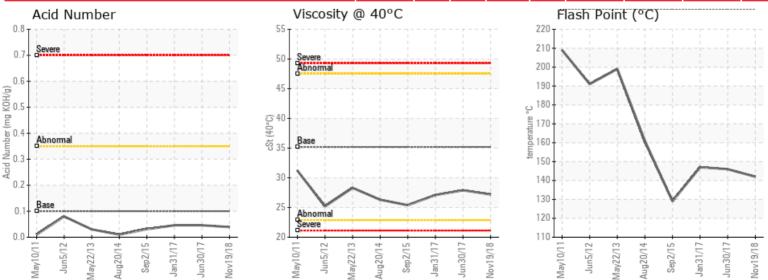
Comments: The oil is about 10 years old based on 2017 report. The low flash point indicates the degradation of the fluid and braking down the hydrocarbon chains to smaller ones. Your operating temperature is 280 F or 138 C. the open cup flash point is 150 C. These numbers getting very close. It will be a fire hazard if there is a leak into the open air. Acid number is very low which indicates there is not corrosion happening in the system. Have you added any fresh product to the system during 2018. (GCD) 10% Distillation Point is severely low. (GCD) 90% Distillation Point is severely low. (GCD) % < 335°C is abnormally high. (GCD) 50% Distillation Point is marginally low.
