Area
Saugeen Shores SP-17701
Machine Id
12K02B
Component
Grease
Fluid
SKF LGWM 1 (--- LTR)

Customer Id: VESTAS
Sample No.: PP0835287
Lab Number: 02590814
Test Package: GRS 1

GREASE ANALYSIS

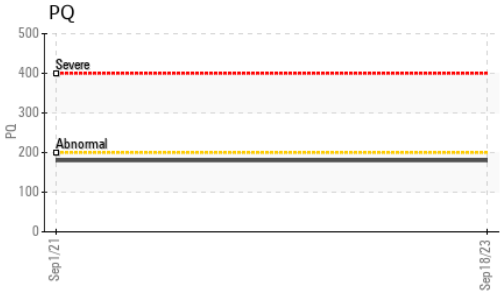
Grease Condition
Grease consistency has changed by 2-1/2 NLGI grades from NLGI 1 to 000-00.

GREASE CONDITION		method	limit/base	current	history1	history2
Grease Color		Visual*	Brown	**Brown**	Tan	---
Texture		In-house*		**Buttery**	Short fiber	---
NLGI Consistency	NLGI Scale	SKF Method*	1	**000-00**	00-0	---

Recommendation
We recommend an early resample to monitor this condition.
