Recommendation: Sample results indicate that the heat transfer fluid is suitable for continued service. Please note reduced flash point and increased % boiloff (GCD % < 335C). That, and also the fluid's viscosity is 30.8 cSt vs 41cSt of new fluid can indicate a mixture of different fluids, but it can also indicate thermal degradation.Depending on system design, that is, if a high blanket gas pressure is not required to provide the circulation pumps positive suction head pressure, it is recommended to perform regular venting of the expansion tank to remove the low boiling vapors from the system. This can help restore distillation values as well as flash point. Water level is not ideal. This may be an indication of where the sample was drawn from. Venting will also assist in removing water from the system if results are representative. Once venting (if safe to do so) has been completed thoroughly, please re-sample in 6 months.

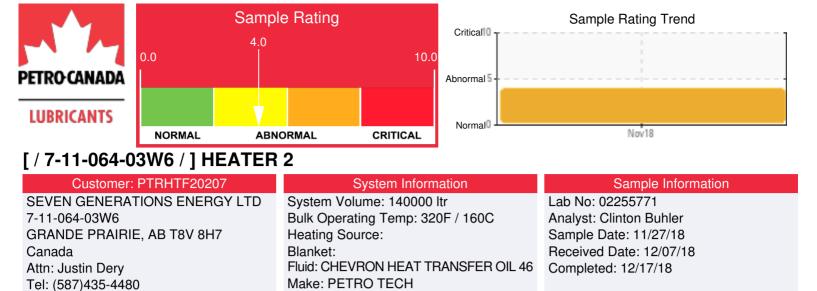
Comments: Water contamination levels are marginally high. COC Flash Point is abnormally low. (GCD) 90% Distillation Point is marginally low.
