OIL ANALYSIS REPORT

Machine Id
9548
Component
Diesel Engine
Fluid
DIESEL ENGINE OIL SAE 15W40 (--- GAL)

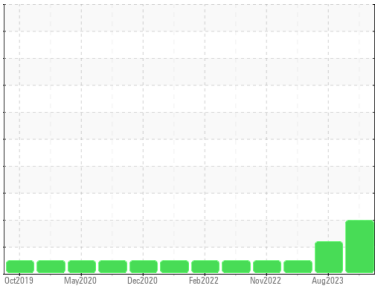
Sample Rating Trend

Wear
Iron ppm levels are abnormal. Cylinder, crank, or cam shaft wear is indicated.

Contamination
Light fuel dilution occurring.

Fluid Condition
Fuel is present in the oil and is lowering the viscosity. The oil is no longer serviceable as a result of the abnormal and/or severe wear.

Recommendation
The oil change at the time of sampling has been noted. We recommend an early resample to monitor this condition.
