## **FREMONT RPG**

Customer: PTRHTF10036	System Information	Sample Information
CERTAINTEED - SAINT GOBAIN	System Volume: 5000 gal	Lab No: 02262942
6400 STEVENSON BLVD	Bulk Operating Temp: 450F / 232C	Analyst: Gaston Arseneault
FREMONT, CA 94538-2468 USA	Heating Source:	Sample Date: 12/19/18
Attn: Dan Arata	Blanket:	Received Date: 01/17/19
Tel: (510)490-0890	Fluid: PETRO CANADA CALFLO HTF	Completed: 01/18/19
E-Mail: dan.d.arata@saint-gobain.com	Make: FIRST THERMAL

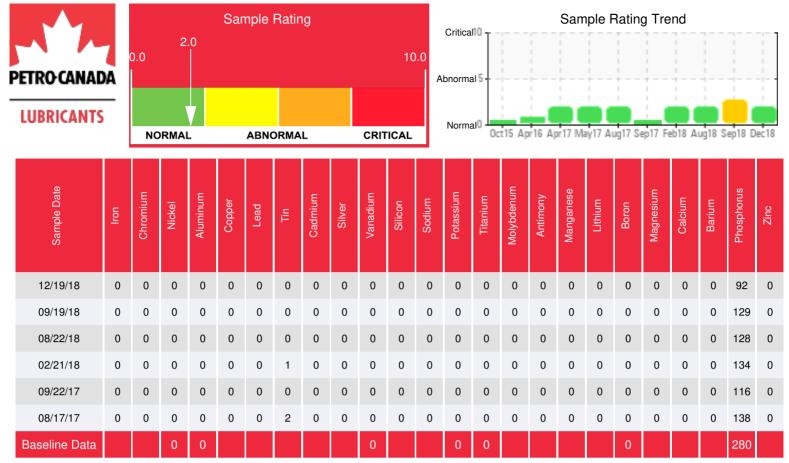
Elemental anaysis results (above) in parts per million (ppm). [10,000 ppm = 1.0%]
