[/ 7-11-064-03W6 /] HEATER 2

SEVEN GENERATIONS ENERGY LTD

Fluid: CHEVRON HEAT TRANSFER OIL 46

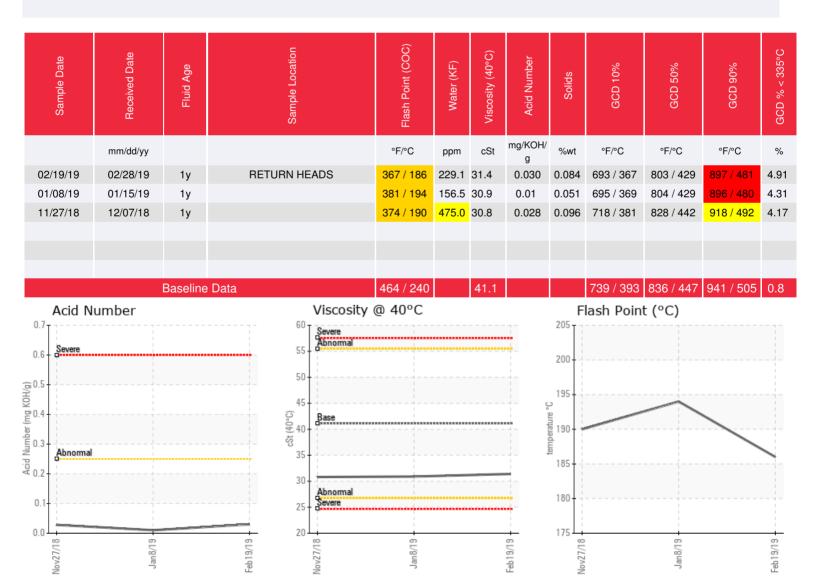
Recommendation: Sample results indicate that the fluid is suitable for continued service. There still appears to be the presence of low boiling vapors that should be vented to help restore the fluid's % boil-off, distillation points, flash point and the viscosity. Results appear to be consistent with the last two analysis. Please re-sample once able to safely vent low boiling vapors.

Sample results indicate that the fluid condition has remained relatively similar to previous analysis on Nov 27, 2018. Flash point and viscosity are steady and % boil-off very similar.10, 50 and 90% distillation values are lower than last analysis. Venting of low boiling vapors is required to help restore distillation values. This can also help restore flash point results. Once safe venting of low boilers has been performed, please re-sample in ~ 6 months.

Sample results indicate that the heat transfer fluid is suitable for continued service. Please note reduced flash point and increased % boil-off (GCD % < 335C). That, and also the fluid's viscosity is 30.8 cSt vs 41cSt of new fluid can indicate a mixture of different fluids, but it can also indicate thermal degradation. Depending on system design, that is, if a high blanket gas pressure is not required to provide the circulation pumps positive suction head pressure, it is recommended to perform regular venting of the expansion tank to remove the low boiling vapors from the system. This can help restore distillation values as well as flash point. Water level is not ideal. This may be an indication of where the sample was drawn from. Venting will also assist in removing water from the system if results are representative. Once venting (if safe to do so) has been completed thoroughly, please re-sample in 6 months. Water contamination levels are marginally high. COC Flash Point is abnormally low. (GCD) 90% Distillation Point is marginally low.
