PROBLEM SUMMARY

Machine Id
SB12MGB
Component
Gearbox
Fluid
GEAR OIL ISO 320 (--- GAL)

OIL ANALYSIS REPORT

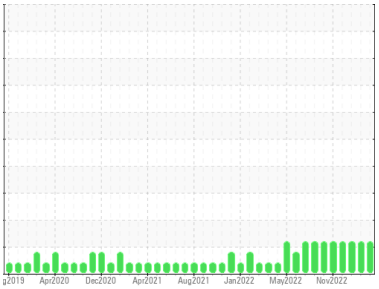
Sample Rating Trend

Sample Status				**ABNORMAL**	ABNORMAL	ABNORMAL
Particles >4µm		ASTM D7647	>40000	▲ **99730**	▲ 94610	▲ 130008
Particles >6µm		ASTM D7647	>5000	▲ **13108**	▲ 10796	▲ 15825
Oil Cleanliness		ISO 4406 (c)	>22/19/16	▲ **24/21/13**	▲ 24/21/12	▲ 24/21/13

Resample at the next service interval to monitor. Due to an abnormal test result it is recommended to contact Stauff Corp at (201)-444-7800 for help resolving the issue.

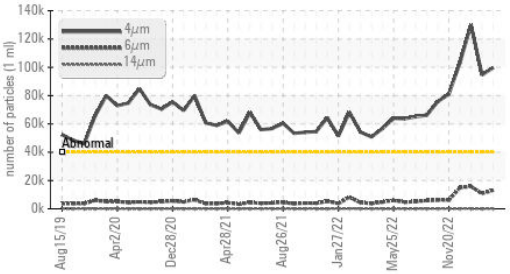
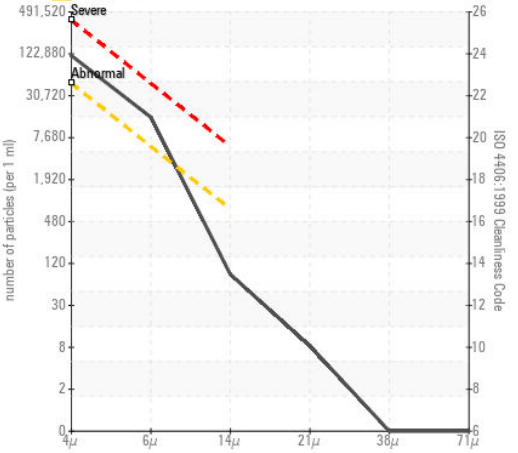
Particle Trend

▲ Contamination
There is a high amount of particulates present in the oil.

FLUID CLEANLINESS		method	limit/base	current	history1	history2
Particles >4µm		ASTM D7647	>40000	▲ **99730**	▲ 94610	▲ 130008
Particles >6µm		ASTM D7647	>5000	▲ **13108**	▲ 10796	▲ 15825
Particles >14µm		ASTM D7647	>640	**74**	32	66
Particles >21µm		ASTM D7647	>160	**7**	2	4
Particles >38µm		ASTM D7647	>40	**0**	0	0
Particles >71µm		ASTM D7647	>10	**0**	0	0
Oil Cleanliness		ISO 4406 (c)	>22/19/16	▲ **24/21/13**	▲ 24/21/12	▲ 24/21/13

▲ Recommendation
Resample at the next service interval to monitor. Due to an abnormal test result it is recommended to contact Stauff Corp at (201)-444-7800 for help resolving the issue.

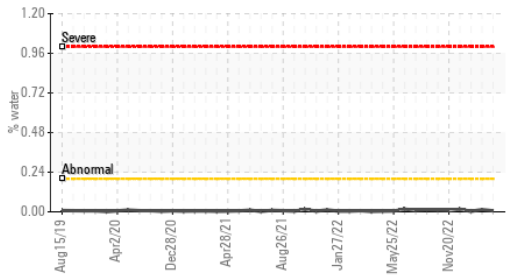
CONTAMINANTS		method	limit/base	current	history1	history2
Silicon	ppm	ASTM D5185m	>50	**<1**	2	1
Sodium	ppm	ASTM D5185m		**<1**	0	0
Potassium	ppm	ASTM D5185m	>20	**0**	1	0
Water	%	ASTM D6304	>0.2	**0.006**	0.014	0.003
ppm Water	ppm	ASTM D6304	>2000	**65.9**	141.5	29.2

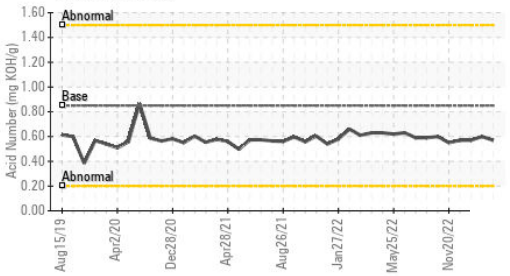
Acid Number

Fluid Condition
The AN level is acceptable for this fluid. The condition of the oil is suitable for further service.

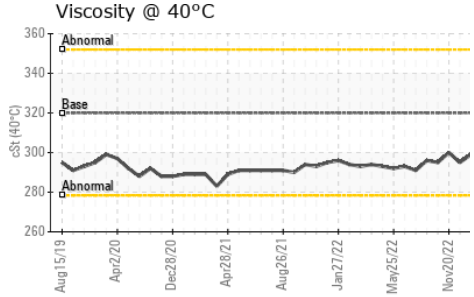
Viscosity @ 40°C

FLUID PROPERTIES		method	limit/base	current	history1	history2
Visc @ 40°C	cSt	ASTM D445	320	**296**	292	299
