PROBLEM SUMMARY

Area
FRONTIER II [200006776]
Machine Id
49WEA86912
Component
Wind Turbine Gearbox
Fluid
FUCHS RENOLIN CLP ISO 320 (--- LTR)

OIL ANALYSIS REPORT

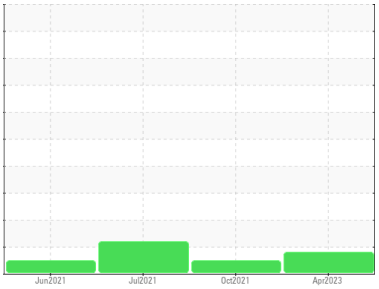
Sample Rating Trend

ATTENTION	NORMAL	ABNORMAL
Sample Status						
Particles >6µm		ASTM D7647	>2500	▲ **3287**	330	▲ 1662
Oil Cleanliness		ISO 4406 (c)	>--/18/15	▲ **22/19/13**	18/16/12	▲ 22/18/14

No corrective action is recommended at this time.
Resample at the next service interval to monitor.

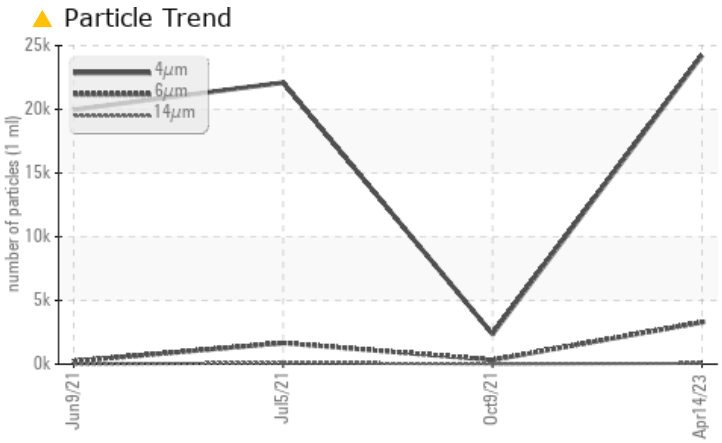
COMPONENT CONDITION SUMMARY

Wear
All component wear rates are normal.

Contamination
There is a moderate amount of silt (particulates < 14 microns in size) present in the oil.

Fluid Condition
The AN level is acceptable for this fluid. The condition of the oil is suitable for further service.

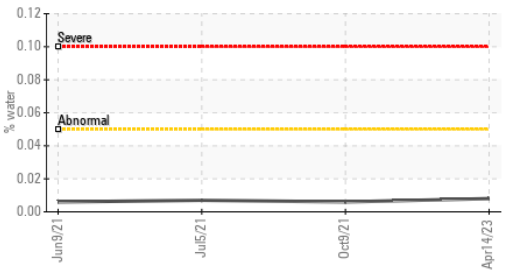
CONTAMINANTS		method	limit/base	current	history1	history2
Silicon	ppm	ASTM D5185m	>50	**4**	4	3
Sodium	ppm	ASTM D5185m	>20	**3**	1	<1
Potassium	ppm	ASTM D5185m	>20	**0**	<1	0
Water	%	ASTM D6304	>0.05	**0.008**	0.006	0.007
ppm Water	ppm	ASTM D6304	>500	**85.1**	65.8	79.2

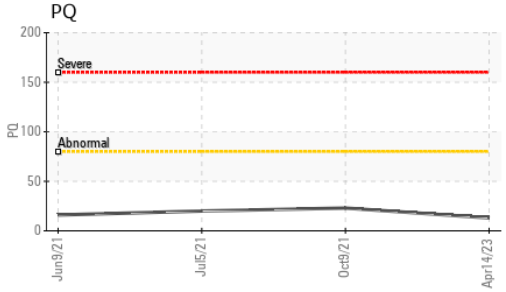
WEAR METALS		method	limit/base	current	history1	history2
PQ		ASTM D8184	>80	**13**	23	20
Iron	ppm	ASTM D5185m	>150	**17**	8	7
Chromium	ppm	ASTM D5185m	>5	**<1**	0	0
Nickel	ppm	ASTM D5185m	>10	**0**	<1	0
Titanium	ppm	ASTM D5185m	>10	**0**	0	0
Silver	ppm	ASTM D5185m		**0**	<1	0
Aluminum	ppm	ASTM D5185m	>10	**<1**	<1	<1
Lead	ppm	ASTM D5185m	>20	**0**	0	0
Copper	ppm	ASTM D5185m	>50	**2**	1	<1
Tin	ppm	ASTM D5185m	>10	**0**	<1	0
Antimony	ppm	ASTM D5185m	>5	**---**	0	0
Vanadium	ppm	ASTM D5185m		**0**	0	0
Cadmium	ppm	ASTM D5185m		**0**	0	0

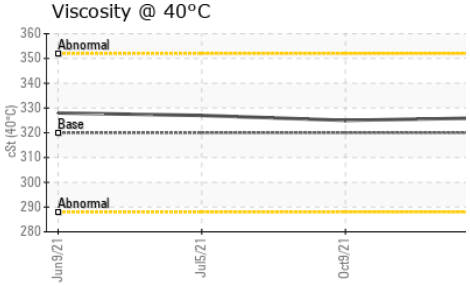
Viscosity @ 40°C

FLUID PROPERTIES		method	limit/base	current	history1	history2
Visc @ 40°C	cSt	ASTM D445	320	**326**	325	327

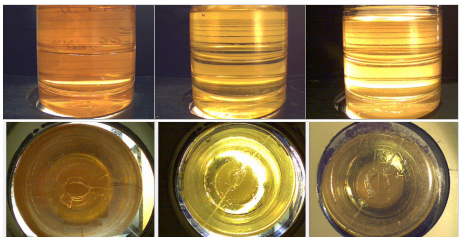
SAMPLE IMAGES	method	limit/base	current	history1	history2
Color					
Bottom

VISUAL		method	limit/base	current	history1	history2
White Metal	scalar	*Visual	NONE	**NONE**	NONE	NONE
Yellow Metal	scalar	*Visual	NONE	**NONE**	NONE	NONE
Precipitate	scalar	*Visual	NONE	**NONE**	NONE	NONE
Silt	scalar	*Visual	NONE	**NONE**	NONE	NONE
Debris	scalar	*Visual	NONE	**NONE**	NONE	NONE
Sand/Dirt	scalar	*Visual	NONE	**NONE**	NONE	NONE
Appearance	scalar	*Visual	NORML	**NORML**	NORML	NORML
Odor	scalar	*Visual	NORML	**NORML**	NORML	NORML
Emulsified Water	scalar	*Visual	>0.05	**NEG**	NEG	NEG
Free Water	scalar	*Visual		**NEG**	NEG	NEG

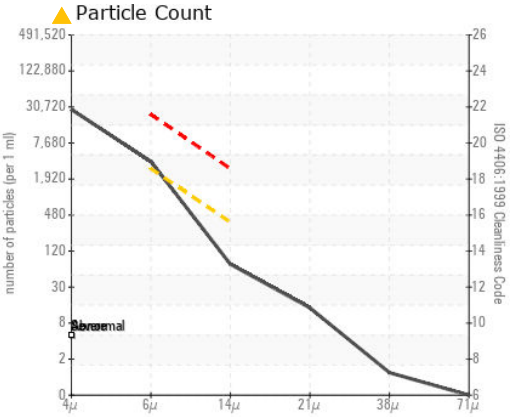
Particle Count

FLUID CLEANLINESS	method	limit/base	current	history1	history2
Particles >4µm	ASTM D7647		**24224**	2353	22097
Particles >6µm	ASTM D7647	>2500	▲ **3287**	330	▲ 1662
Particles >14µm	ASTM D7647	>320	**64**	24	▲ 91
Particles >21µm	ASTM D7647	>80	**12**	4	▲ 18
Particles >38µm	ASTM D7647	>20	**1**	0	2
Particles >71µm	ASTM D7647	>4	**0**	0	0
Oil Cleanliness	ISO 4406 (c)	>--/18/15	▲ **22/19/13**	18/16/12	▲ 22/18/14

Recommendation
No corrective action is recommended at this time. Resample at the next service interval to monitor.

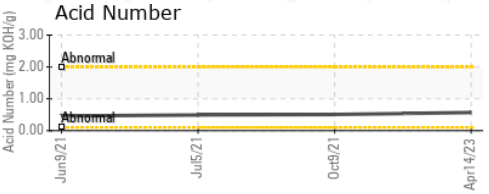
FLUID DEGRADATION		method	limit/base	current	history1	history2
Acid Number (AN)	mg KOH/g	ASTM D8045		**0.57**	0.507	0.493
