CARGILL MEAT

Customer: PTRHTF60010	System Information	Sample Information
SYNLUBE INTERNATIONAL CO LTD 76/1 MOO.7 THACHIN MUANG SAMUTSAKHON, 74000 THAILAND Attn: CHERNPORN CHOBKUI Tel: 034421290 E-Mail: chernporn@synlube.co.th	System Volume: 9225 ltr Bulk Operating Temp: 554F / 290C Heating Source: Blanket: Fluid: PETRO CANADA PURITY FG HEAT TRANSFER FLUID Make: WANSON	Lab No: 02271409 Analyst: Yutong Gao Sample Date: 02/21/19 Received Date: 03/05/19 Completed: 03/07/19

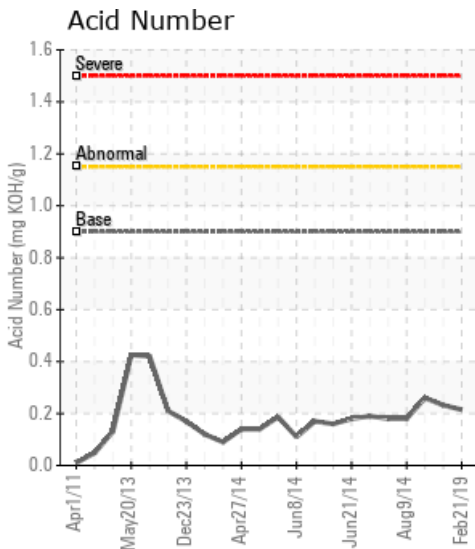
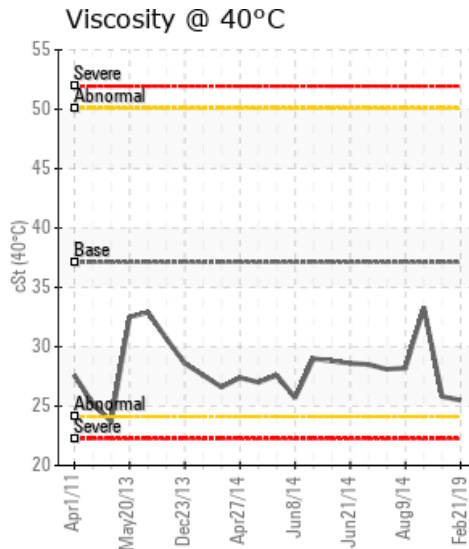
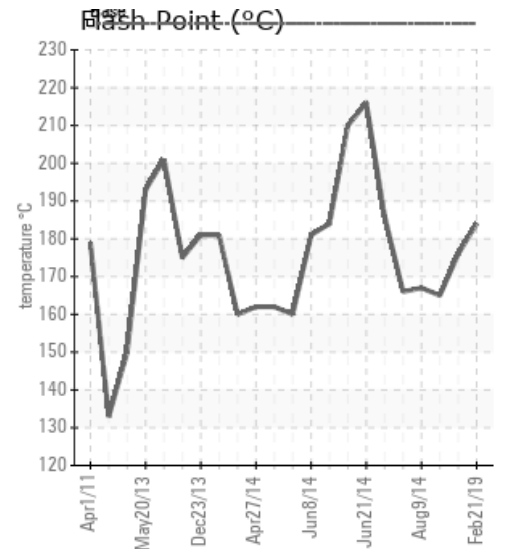
Sample Date	Received Date	Fluid Age	Sample Location	Flash Point (COC)	Water (KF)	Viscosity (40°C)	Acid Number	Solids	GCD 10%	GCD 50%	GCD 90%	GCD % < 335°C
	mm/dd/yy			°F/°C	ppm	cSt	mg/KOH/g	%wt	°F/°C	°F/°C	°F/°C	%
02/21/19	03/05/19	34m	RETURN	363 / 184	7.2	25.5	0.215	0.055	650 / 343	787 / 420	880 / 471	8.32
02/20/19	03/05/19	34m	SUPPLY	349 / 176	9.9	25.8	0.232	0.080	623 / 328	783 / 417	880 / 471	10.32
01/11/17	01/23/17	9m	SUPPLY/RETURN	329 / 165	9.7	33.3	0.26	0.042	688 / 364	803 / 428	897 / 480	5.05
08/09/14	08/19/14	16m	RETURN	333 / 167	20.0	28.2	0.18	0.127	698 / 370	804 / 429	899 / 482	3.72
08/08/14	08/19/14	16m	SUPPLY	331 / 166	20.5	28.1	0.18	0.116	676 / 358	802 / 428	903 / 484	6.29
06/22/14	07/03/14	14m	RETURN	367 / 186	31.9	28.5	0.19	0.100	684 / 362	803 / 429	896 / 480	5.59
Baseline Data				459 / 237		37.12	0.90		721 / 383	807 / 431	892 / 478	1.5

Comments: COC Flash Point is low. (GCD) % < 335°C is high. (GCD) 10% Distillation Point is low.
