SUPPLY CARGILL MEAT THAILAND

Customer: PTRHTF60010	System Information	Sample Information
SYNLUBE INTERNATIONAL CO LTD 76/1 MOO.7 THACHIN MUANG SAMUTSAKHON, 74000 THAILAND Attn: CHERNPORN CHOBKUI Tel: 034421290 E-Mail: chernporn@synlube.co.th	System Volume: 20910 ltr Bulk Operating Temp: 554F / 290C Heating Source: Blanket: Fluid: PETRO CANADA PURITY FG HEAT TRANSFER FLUID Make: WANSON	Lab No: 02290392 Analyst: Yutong Gao Sample Date: 06/02/19 Received Date: 06/11/19 Completed: 06/13/19

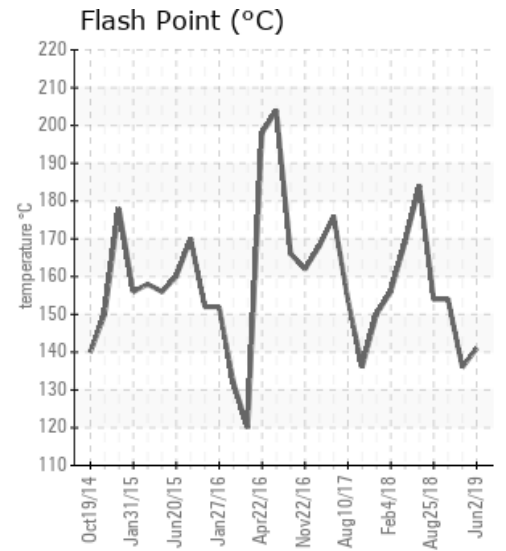
Recommendation: The current fluid conditions are slightly better than the previous oil sample two months ago. However, the flash point is still severely low considering the elevated low boiler generated by the thermal cracking? The oil Acid Number and Solid contents are all low. Please conduct a long and effective system venting to release the light oil moisture.

Sample Date	Received Date	Fluid Age	Sample Location	Flash Point (COC)	Water (KF)	Viscosity (40°C)	Acid Number	Solids	GCD 10%	GCD 50%	GCD 90%	GCD % < 335°C
	mm/dd/yy			°F/°C	ppm	cSt	mg/KOH/g	%wt	°F/°C	°F/°C	°F/°C	%
06/02/19	06/11/19	38m		286 / 141	9.9	26.3	0.266	0.054	654 / 346	792 / 422	890 / 477	8.10
05/02/19	05/03/19	36m		277 / 136	8.5	26.1	0.241	0.061	685 / 363	803 / 428	897 / 481	5.37
02/01/19	02/08/19	0m		309 / 154	17.7	25.8	0.190	0.023	620 / 327	773 / 412	871 / 466	10.77
08/25/18	11/27/18	31m		309 / 154	12.2	26.4	0.08	0.023	598 / 314	728 / 386	821 / 439	15.22
08/25/18	09/05/18	28m	SUPPLU	363 / 184	11.7	28.4	0.10	0.025	685 / 363	805 / 430	902 / 483	5.29
05/23/18	06/12/18	25m		336 / 169	12.7	30.3	0.17	0.048	677 / 359	781 / 416	873 / 467	4.51
02/04/18	02/26/18	22m		313 / 156	0.00	27.7	0.276	0.036	665 / 352	769 / 409	890 / 477	4.38
11/01/17	11/14/17	19m		302 / 150	10.7	26.9	0.13	0.031	674 / 357	805 / 430	897 / 481	6.43
