Customer Id: ENEAST
Sample No.: RP0033011
Lab Number: 05898674
Test Package: IND 2

OIL ANALYSIS REPORT

Machine Id
MHTF_1B MHTF_1B_M1
Component
Drive End Bearing
Fluid
ROYAL PURPLE SYNFILM GT 32 (--- GAL)

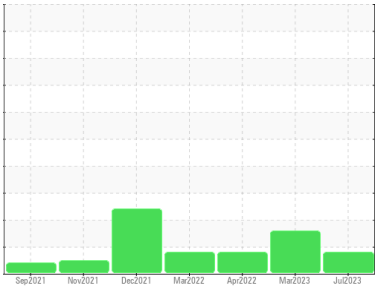
Sample Rating Trend

WEAR

▲ Non-ferrous Metals

Sample Status				**ABNORMAL**	ABNORMAL	ABNORMAL
Lead	ppm	ASTM D5185m	>20	▲ **32**	▲ 56	▲ 22

No corrective action is recommended at this time.
Resample at the next service interval to monitor.

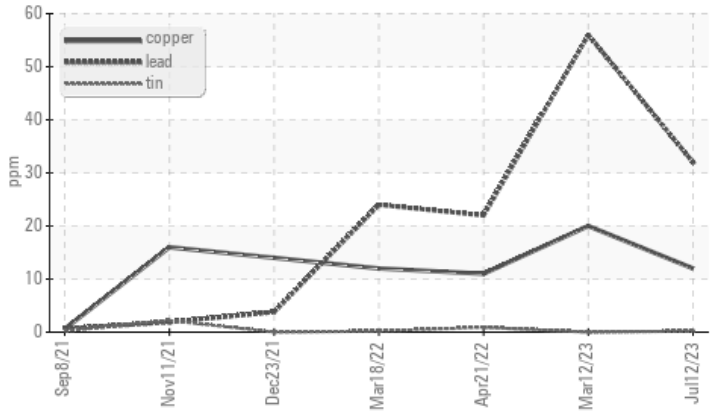
▲ Wear
Bearing wear is indicated.

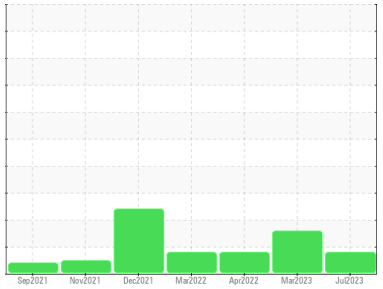
Sample Rating Trend

Contamination
There is no indication of any contamination in the oil.

Fluid Condition
The AN level is acceptable for this fluid. The condition of the oil is suitable for further service.

▲ Recommendation
No corrective action is recommended at this time. Resample at the next service interval to monitor.

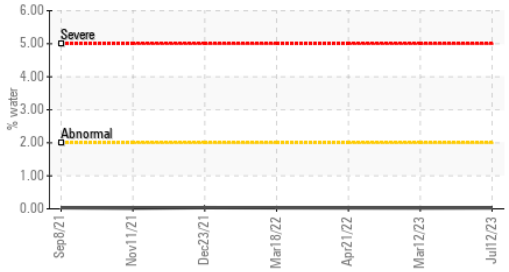
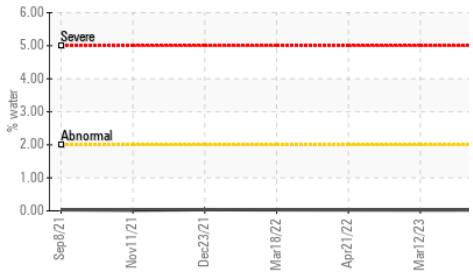
CONTAMINANTS		method	limit/base	current	history1	history2
Silicon	ppm	ASTM D5185m	>15	**2**	5	6
Sodium	ppm	ASTM D5185m		**<1**	<1	2
Potassium	ppm	ASTM D5185m	>20	**<1**	0	0
Water	%	ASTM D6304	>2	**0.026**	0.023	0.027
ppm Water	ppm	ASTM D6304		**260.3**	233.9	273.7

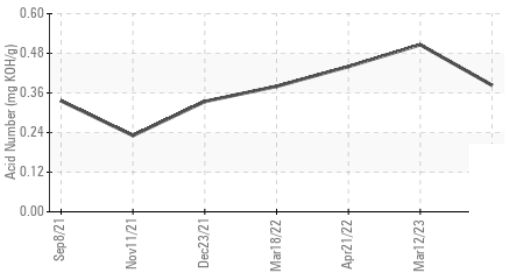
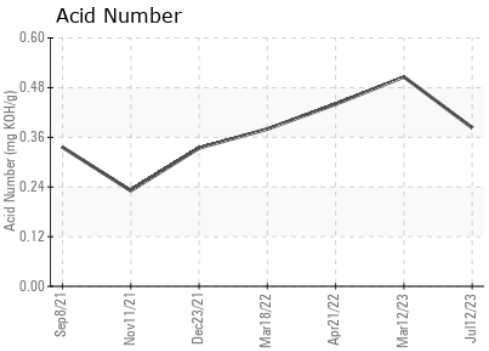
FLUID DEGRADATION		method	limit/base	current	history1	history2
Acid Number (AN)	mg KOH/g	ASTM D8045		**0.383**	0.506	0.44

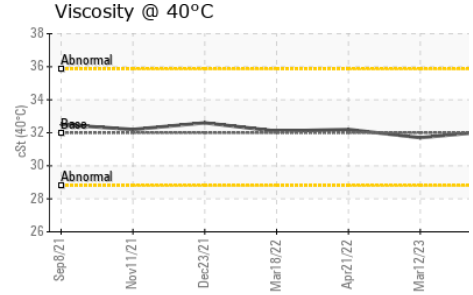
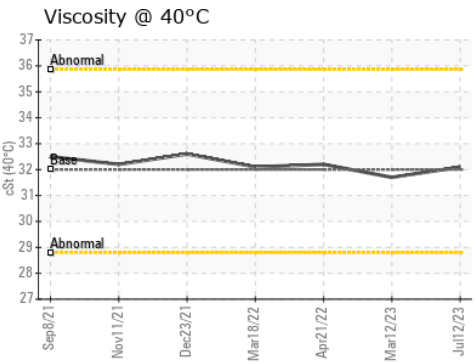
Viscosity @ 40°C

FLUID PROPERTIES		method	limit/base	current	history1	history2
Visc @ 40°C	cSt	ASTM D445	32	**32.1**	31.7	32.2

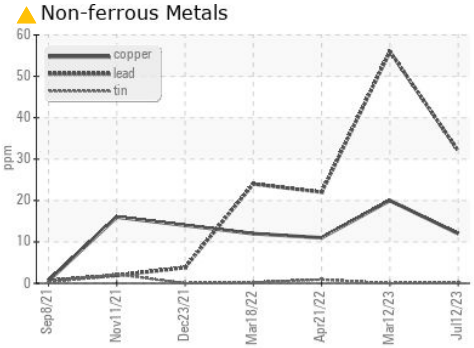
Non-ferrous Metals

WEAR METALS		method	limit/base	current	history1	history2
Iron	ppm	ASTM D5185m	>20	**<1**	0	<1
Chromium	ppm	ASTM D5185m	>20	**0**	0	0
Nickel	ppm	ASTM D5185m	>20	**<1**	0	<1
Titanium	ppm	ASTM D5185m		**0**	0	0
Silver	ppm	ASTM D5185m		**0**	0	<1
Aluminum	ppm	ASTM D5185m	>20	**<1**	<1	<1
Lead	ppm	ASTM D5185m	>20	▲ **32**	▲ 56	▲ 22
Copper	ppm	ASTM D5185m	>20	**12**	▲ 20	11
Tin	ppm	ASTM D5185m	>20	**<1**	0	<1
Vanadium	ppm	ASTM D5185m		**0**	<1	0
Cadmium	ppm	ASTM D5185m		**0**	0	0
