OIL ANALYSIS REPORT

Area
HIGHLAND [200005319]
Machine Id
14WEA80821
Component
Wind Turbine Gearbox
Fluid
MOBIL XMP 320 (--- LTR)

NORDEX USA - HIGHLAND & HIGHLAND NORTH
300 SOUTH WACKER DRIVE, SUITE 1500
CHICAGO, IL
US 60606
Contact: Robert Warner
rwarner@everpower.com
T: x:
F: x:

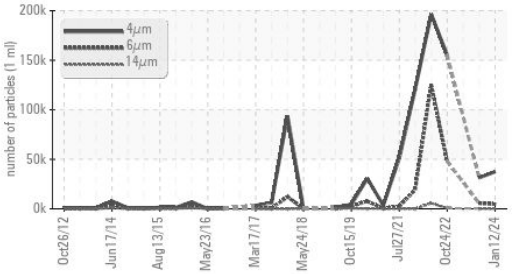
Particle Trend

▲ Contamination
There is a moderate amount of silt (particulates < 14 microns in size) present in the oil.

▲ Recommendation
No corrective action is recommended at this time. Resample at the next service interval to monitor.

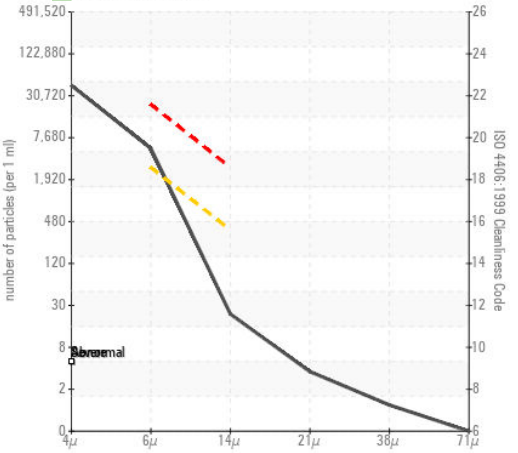
Particle Count

FLUID CLEANLINESS		method	limit/base	current	history1	history2
Particles >4µm		ASTM D7647		**37476**	31274	---
Particles >6µm		ASTM D7647	>2500	**▲ 4685**	▲ 5678	---
Particles >14µm		ASTM D7647	>320	**20**	154	---
Particles >21µm		ASTM D7647	>80	**3**	30	---
Particles >38µm		ASTM D7647	>20	**1**	1	---
Particles >71µm		ASTM D7647	>4	**0**	0	---
Oil Cleanliness		ISO 4406 (c)	>--/18/15	**▲ 22/19/11**	▲ 22/20/14	---
