GFPT-FURTHER#3#4

Customer: PTRHTF60010	System Information	Sample Information
SYNLUBE INTERNATIONAL CO LTD 76/1 MOO.7 THACHIN MUANG SAMUTSAKHON, 74000 THAILAND Attn: Kittisak Suthithanakom Tel: 6(681)850-1907 E-Mail: kittisak@synlube.co.th	System Volume: 14350 ltr Bulk Operating Temp: 554F / 290C Heating Source: Blanket: Fluid: PETRO CANADA PURITY FG HEAT TRANSFER FLUID Make: HOVAL	Lab No: 02312789 Analyst: Philip Riley Sample Date: 08/15/19 Received Date: 10/04/19 Completed: 10/17/19

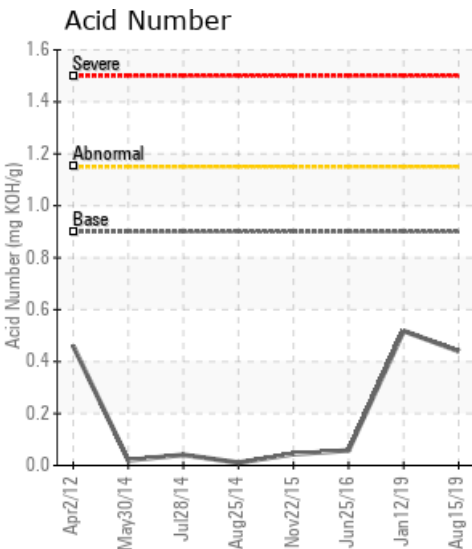
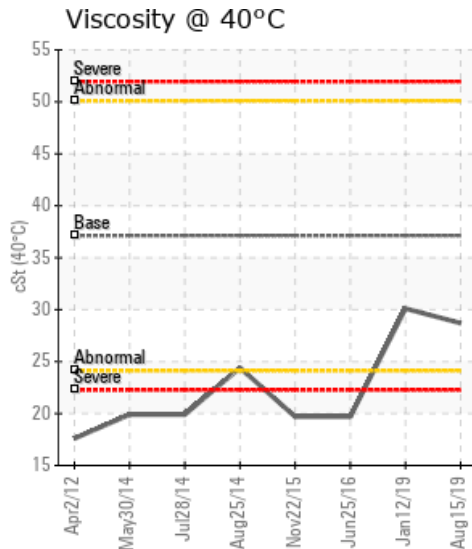
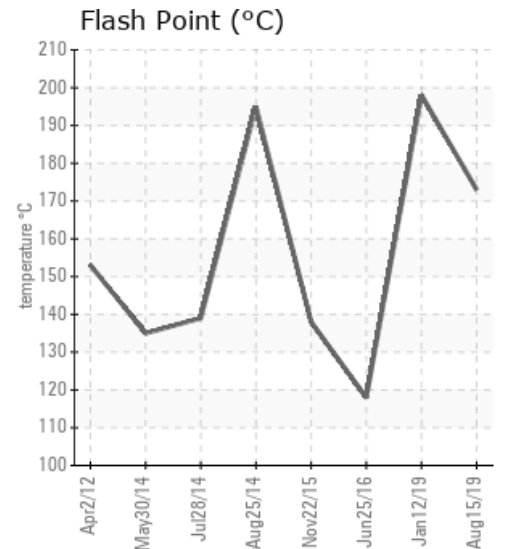
Sample Date	Received Date	Fluid Age	Sample Location	Flash Point (COC)	Water (KF)	Viscosity (40°C)	Acid Number	Solids	GCD 10%	GCD 50%	GCD 90%	GCD % < 335°C
	mm/dd/yy			°F/°C	ppm	cSt	mg/KOH/g	%wt	°F/°C	°F/°C	°F/°C	%
08/15/19	10/04/19	16m	SUPPLY RETURN	343 / 173	10.4	28.7	0.440	0.055	717 / 381	828 / 442	920 / 493	3.19
01/12/19	03/05/19	8m	SUPPLY RETURN	388 / 198	7.6	30.1	0.518	0.041	687 / 364	798 / 426	891 / 477	4.44
06/25/16	07/11/16	6m		244 / 118	13.3	19.7	0.058	0.057	600 / 316	762 / 406	944 / 507	13.48
11/22/15	11/30/15	52m		280 / 138	2107.3	19.7	0.044	0.137	587 / 308	753 / 401	919 / 493	15.15
08/25/14	08/28/14	52m	SUPPLY/RETURN	383 / 195	1.6	24.4	0.011	0.091	632 / 333	766 / 408	953 / 511	9.92
07/28/14	08/05/14	51m	SUPPLY	282 / 139	11.3	19.9	0.041	0.051	626 / 330	767 / 408	949 / 510	10.59
Baseline Data				459 / 237		37.12	0.90		721 / 383	807 / 431	892 / 478	1.5

Comments: COC Flash Point is severely low. (GCD) 90% Distillation Point is abnormally high.
