OIL ANALYSIS REPORT

Area
RIG 879
Machine Id
R879-MP-02
Component
Gearbox
Fluid
GEAR OIL ISO 320 (--- GAL)

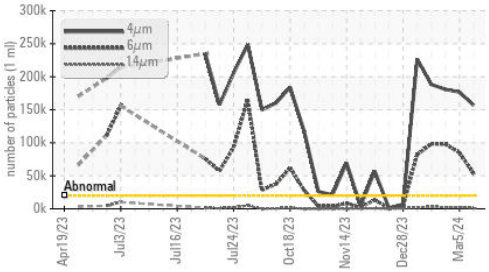
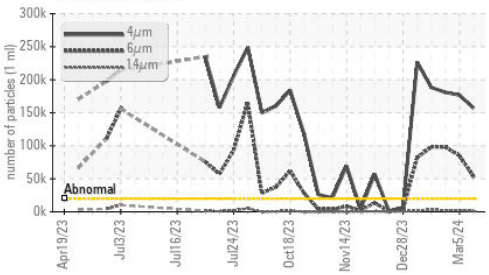
Contamination
There is a high amount of particulates present in the oil.

FLUID CLEANLINESS		method	limit/base	current	history1	history2
Particles >4µm		ASTM D7647	>20000	▲ **156838**	▲ 176742	▲ 180816
Particles >6µm		ASTM D7647	>5000	▲ **53519**	▲ 84787	▲ 97750
Particles >14µm		ASTM D7647	>640	▲ **909**	▲ 2264	▲ 2193
Particles >21µm		ASTM D7647	>160	▲ **144**	▲ 310	▲ 195
Particles >38µm		ASTM D7647	>40	**5**	3	3
Particles >71µm		ASTM D7647	>10	**0**	1	0
Oil Cleanliness		ISO 4406 (c)	>21/19/16	▲ **24/23/17**	▲ 25/24/18	▲ 25/24/18

Recommendation
We recommend you service the filters on this component if applicable. Resample at the next service interval to monitor.
