HEAT TRANSFER

Customer: PTRHTF10164	System Information	Sample Information
Malarkey Roofing 3400 S. Council Rd OKLAHOMA CITY, OK 73179 USA Attn: Will Perry Tel: (405)843-1833 E-Mail: will.perry@reladyne.com	System Volume: 600 gal Bulk Operating Temp: 565F / 296C Heating Source: Blanket: Fluid: PETRO CANADA CALFLO HTF Make: AMERICAN HEATING	Lab No: 02314437 Analyst: Garrett Bapp Sample Date: 10/01/19 Received Date: 10/15/19 Completed: 10/25/19

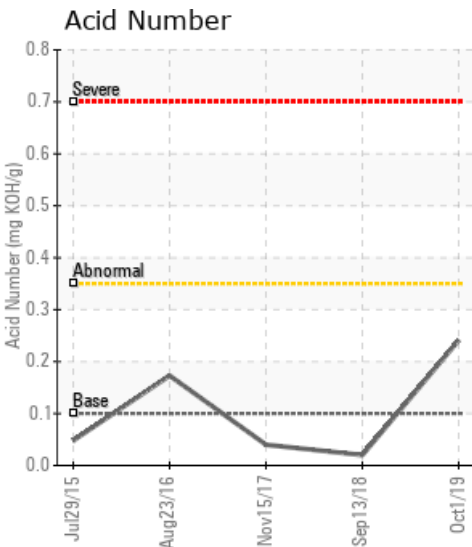
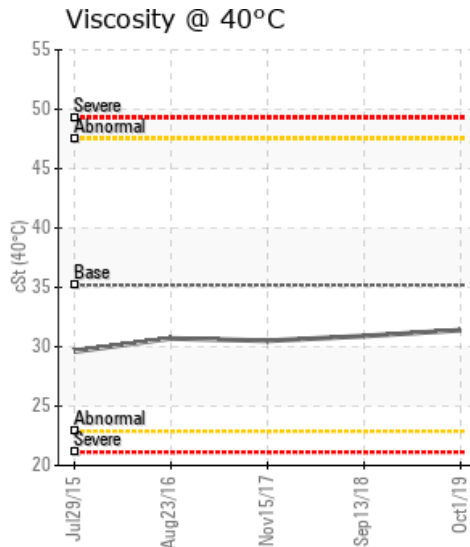
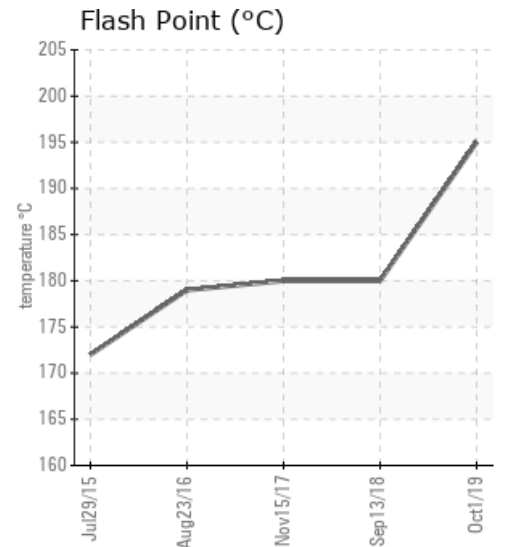
Sample Date	Received Date	Fluid Age	Sample Location	Flash Point (COC)	Water (KF)	Viscosity (40°C)	Acid Number	Solids	GCD 10%	GCD 50%	GCD 90%	GCD % < 335°C
	mm/dd/yy			°F/°C	ppm	cSt	mg/KOH/g	%wt	°F/°C	°F/°C	°F/°C	%
10/01/19	10/15/19	5y		383 / 195	12.8	31.4	0.241	0.210	726 / 386	821 / 438	936 / 502	0.00
09/13/18	10/18/18	7y		356 / 180	16.5	30.9	0.02	0.054	705 / 374	791 / 422	895 / 480	0.36
11/15/17	11/16/17	6y		356 / 180	142.9	30.5	0.04	0.045	643 / 339	789 / 420	905 / 485	8.85
08/23/16	10/27/16	1y		354 / 179	6.2	30.7	0.173	0.003	682 / 361	800 / 427	928 / 498	5.08
07/29/15	08/21/15	2y		342 / 172	13.9	29.6	0.048	0.057	715 / 379	806 / 430	906 / 485	0.00
Baseline Data				448 / 231		35.20	.1		712 / 378	810 / 432	910 / 488	1.75

Recommendation: Fluid is suitable for continued use. There is evidence of oxidation and thermal cracking. Acid number is rising. Viscosity is slightly reduced but still within viscosity grade. Flash point is 36°C lower than specified for new fluid. (GCD) 90% Distillation Point is slightly elevated. Pentane Insolubles has increased from previous sample. To increase the longevity of fluid, vent low boilers and a 20% drain and refill during the next system shutdown should help. Continue monitoring and yearly sampling.
