## [KEYERA PARTNERSHIP / 3-12-46-14W5M] PLT2

Customer: PTRHTF30084	System Information	Sample Information
Keyera Partnership Brazeau River Ga... Box 7318 3-12-46-14W5 Drayton Valley, AB T7A 1S5 Canada Attn: Ken Bouchard Tel: (780)894-3601 E-Mail: ken_bouchard@keyera.com	System Volume: 20000 ltr Bulk Operating Temp: 455F / 235C Heating Source: Blanket: Fluid: PETRO CANADA PETRO-THERM Make: PETROTHERM ENG.	Lab No: 02321347 Analyst: Kevin McDermott Sample Date: 11/13/19 Received Date: 11/20/19 Completed: 11/25/19

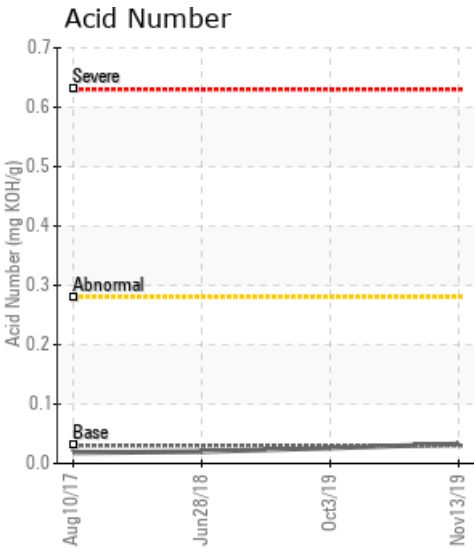
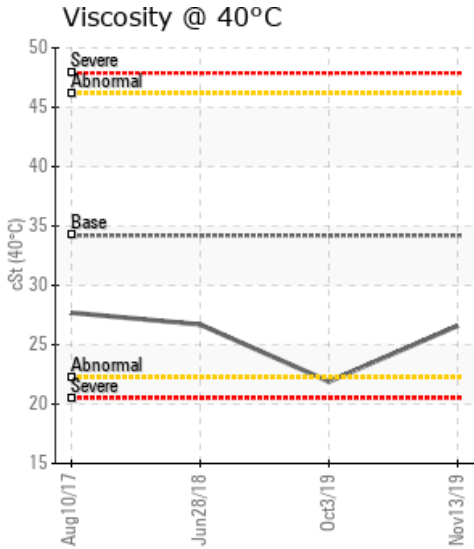
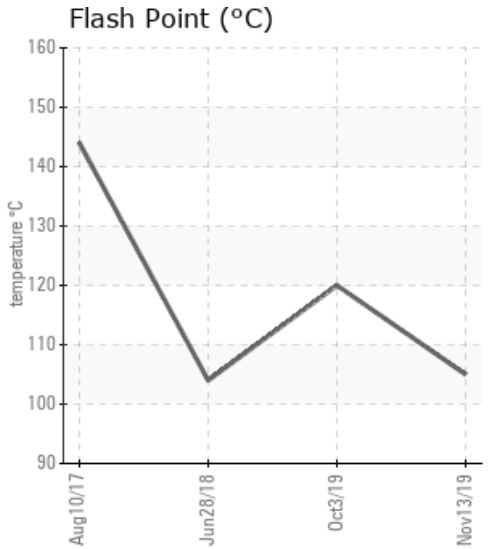
Sample Date	Received Date	Fluid Age	Sample Location	Flash Point (COC)	Water (KF)	Viscosity (40°C)	Acid Number	Solids	GCD 10%	GCD 50%	GCD 90%	GCD % < 335°C
	mm/dd/yy			°F/°C	ppm	cSt	mg/KOH/g	%wt	°F/°C	°F/°C	°F/°C	%
11/13/19	11/20/19	0y	PUMP DISCHARGE	221 / 105	67.0	26.6	0.033	0.085	649 / 343	782 / 417	886 / 474	8.27
10/03/19	10/30/19	9y	TANK	248 / 120	70.2	21.9	0.026	0.052	681 / 361	797 / 425	897 / 481	4.97
06/28/18	07/10/18	0y	MAIN PUMP	219 / 104	37.9	26.7	0.02	0.016	700 / 371	806 / 430	904 / 484	3.23
08/10/17	08/22/17	2y	AT THE PUMP	291 / 144	16.9	27.7	0.018	0.027	689 / 365	801 / 427	903 / 484	4.43
Baseline Data				433 / 223		34.2	0.03		720 / 382	817 / 436	900 / 482	1.00

Recommendation: The very low flash point combined with low viscosity are symptoms of thermal cracking, but given the history of this system likely from a prior exchanger leak. Fortunately these low values are not significantly worsening since previous sample. Suggest submitting annual samples or sooner if fluid becomes stressed or if exchanger leak is suspected.
