OIL ANALYSIS REPORT

Machine Id
SJNM03BE
Component
Biogas Engine
Fluid
CHEVRON HDAX 9500 GAS ENGINE OIL 40 (--- GAL)

SAMPLE INFORMATION		method	limit/base	current	history1	history2
Sample Number		Client Info		**WC0865727**	WC0865743	WC0865694
Sample Date		Client Info		**12 May 2024**	02 May 2024	26 Apr 2024
Machine Age	hrs	Client Info		**0**	116445	116347
Oil Age	hrs	Client Info		**0**	336	238
Oil Changed		Client Info		**N/A**	Not Changd	Not Changd
Sample Status				**ABNORMAL**	NORMAL	NORMAL

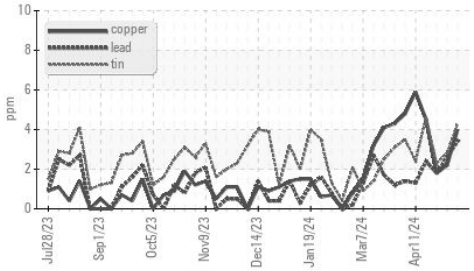
Non-ferrous Metals

Wear
The tin level is abnormal. All other component wear rates are normal.

Recommendation
No corrective action is recommended at this time. Resample at the next service interval to monitor.
