CICERO, IL 60804 USA Attn: Richard Jania Tel: (708)652-0575 E-Mail: richard.jania@veolia.com System Volume: 36200 gaiLabBulk Operating Temp: 585F / 307CAnalHeating Source:SamBlanket:ReceFluid: CHEVRON HEAT TRANSFER OIL 46ComMake: GTS ENERGY INCYvet

Analyst: Yvette Trzcinski Sample Date: 01/10/20 Received Date: 01/21/20 Completed: 01/28/20 Yvette Trzcinski yvette.trzcinski@petrocanadalsp.com

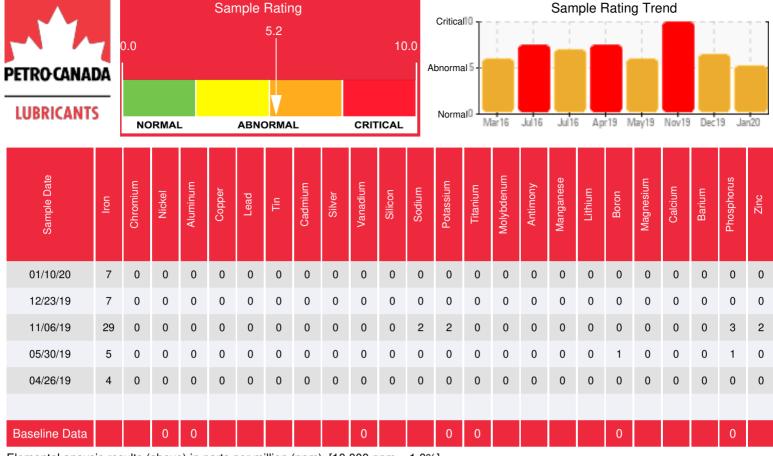
Elemental anaysis results (above) in parts per million (ppm). [10,000 ppm = 1.0%]
