SOUTH HEATER

System Information

Fluid: PETRO CANADA CALFLO HTF

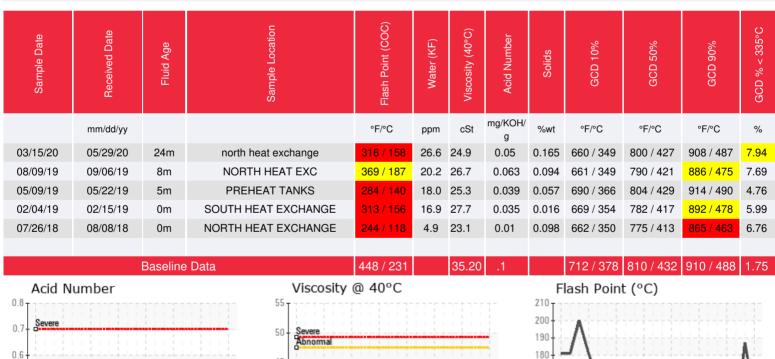
Recommendation: COC Flash Point is very low. A low flash point can indicate thermal degradation. Add new oil to bring up Flash Point. (GCD) % < 335°C is marginally high. Make sure the oil was purged before collection into the sample container to get the best sample.

Comments: COC Flash Point is severely low. (GCD) % < 335°C is marginally high.
