[KEYERA PARTNERSHIP / 3-12-46-14W5] PLT2

Customer: PTRHTF30084	System Information	Sample Information
Keyera Partnership Brazeau River Ga... Box 7318 Drayton Valley, AB T7A 1S5 Canada Attn: Don Renner Tel: (780)894-3601 E-Mail: don_renner@keyera.com	System Volume: 14000 ltr Bulk Operating Temp: 455F / 235C Heating Source: Blanket: Fluid: PETRO CANADA PETRO-THERM Make: PETROTHERM ENG.	Lab No: 02364497 Analyst: Kevin McDermott Sample Date: 07/05/20 Received Date: 07/14/20 Completed: 08/04/20 Kevin McDermott kevin.mcdermott@petrocanadalsp.com

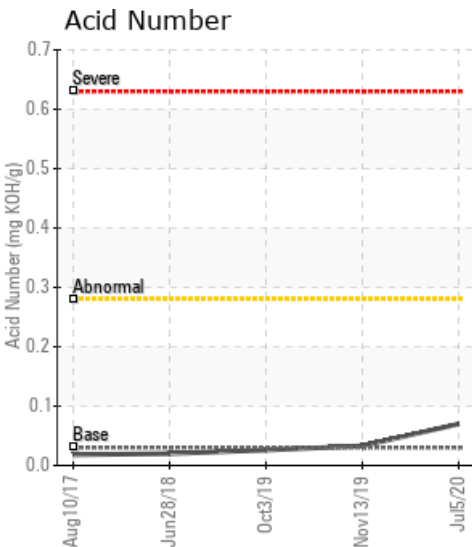
Sample Date	Received Date	Fluid Age	Sample Location	Flash Point (COC)	Water (KF)	Viscosity (40°C)	Acid Number	Solids	GCD 10%	GCD 50%	GCD 90%	GCD % < 335°C
	mm/dd/yy			°F/°C	ppm	cSt	mg/KOH/g	%wt	°F/°C	°F/°C	°F/°C	%
07/05/20	07/14/20	5y		241 / 116	245.8	26.1	0.07	0.030	691 / 366	808 / 431	906 / 486	5.62
11/13/19	11/20/19	0y	PUMP DISCHARGE	221 / 105	67.0	26.6	0.033	0.085	649 / 343	782 / 417	886 / 474	8.27
10/03/19	10/30/19	9y	TANK	248 / 120	70.2	21.9	0.026	0.052	681 / 361	797 / 425	897 / 481	4.97
06/28/18	07/10/18	0y	MAIN PUMP	219 / 104	37.9	26.7	0.02	0.016	700 / 371	806 / 430	904 / 484	3.23
08/10/17	08/22/17	2y	AT THE PUMP	291 / 144	16.9	27.7	0.018	0.027	689 / 365	801 / 427	903 / 484	4.43
Baseline Data				433 / 223		34.2	0.03		720 / 382	817 / 436	900 / 482	1.00

Recommendation: Fluid remains in good condition overall. The viscosity is slightly low and the flash point is really low. Given the history of this system, these lower values are likely from a previous exchanger leak. Continue to submit annual samples to proactively monitor fluid condition.

11/13/19	The very low flash point combined with low viscosity are symptoms of thermal cracking, but given the history of this system likely from a prior exchanger leak. Fortunately these low values are not significantly worsening since previous sample. Suggest submitting annual samples or sooner if fluid becomes stressed or if exchanger leak is suspected.
10/03/19	The reduced viscosity and severely reduced flash point suggest an exchanger leak since the previous sample June 2018. Suggest taking another sample to see if FP / visc are continuing to drop. COC Flash Point is severely low. Visc @ 40°C is abnormally low.
06/28/18	Flash point is very low, viscosity slightly lower, both caused by dilution from blanket gas, or early signs of thermal cracking. Suggest venting off light ends from fluid. COC Flash Point is severely low.
08/10/17	Reduced flash point and viscosity indicate that some thermal cracking of the fluid has taken place, which is caused by excessive skin film temperature at the heat source. However, fluid remains in good condition. Suggest annual sample submissions. COC Flash Point is severely low. Viscosity slightly low.
