VTA HOT OIL PUMP

ADM VITAMIN E PLANT 3700 EAST DIVISION STREET DECATUR, IL 62526 USA

System Information

Sample Information

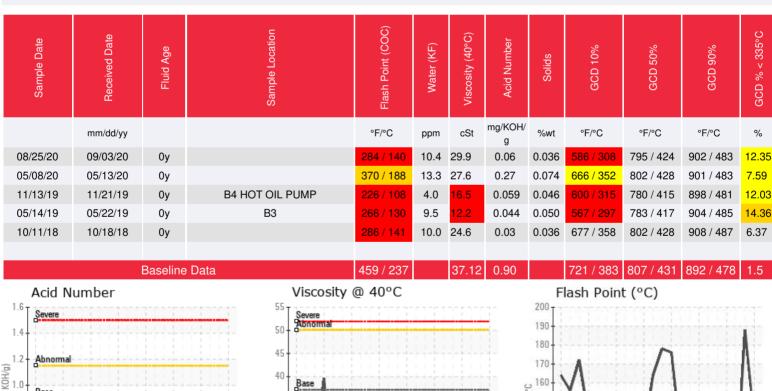
Comments: (GCD) 10% Distillation Point is severely low. COC Flash Point is severely low. (GCD) % < 335°C is abnormally high.

Recommendation: We are starting to see signs of significant cracking with low boilers passing the 12% mark and flash point at 140 C. Once the GCD <335 exceed 15% we recommend changing. I would shorten the sampling cycle by half to see what the oil looks like in mid October. Should look to change by November or do a partial exchange.

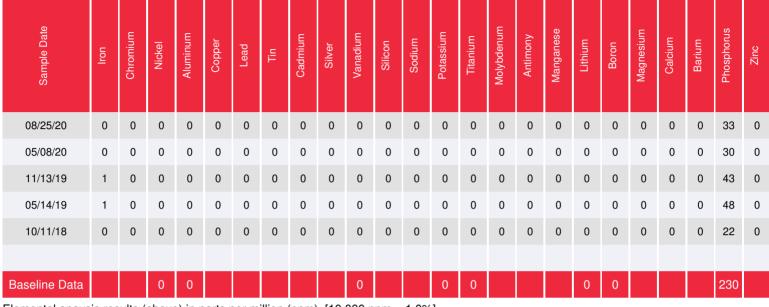
Elemental analysis results (above) in parts per million (ppm). [10,000 ppm = 1.0%]
