TFS H/O SYSTEM #2

Customer: PTRHTF10176	System Information	Sample Information
CERTAINTEED ROOFING	System Volume: 3738 gal	Lab No: 02376396
100 CERTAINTEED DR	Bulk Operating Temp: 525F / 274C	Analyst: Joe Goecke
JONESBURG, MO 63351 USA	Heating Source:	Sample Date: 01/07/20
Attn: Jeff Montgomery	Blanket:	Received Date: 09/17/20
Tel: (952)261-9532	Fluid: PETRO CANADA CALFLO AF	Completed: 09/23/20
E-Mail: jeffrey.d.montgomery@saint-	Make: FSE	Joe Goecke
gobain.com		Joe.goecke@petrocanadalsp.com

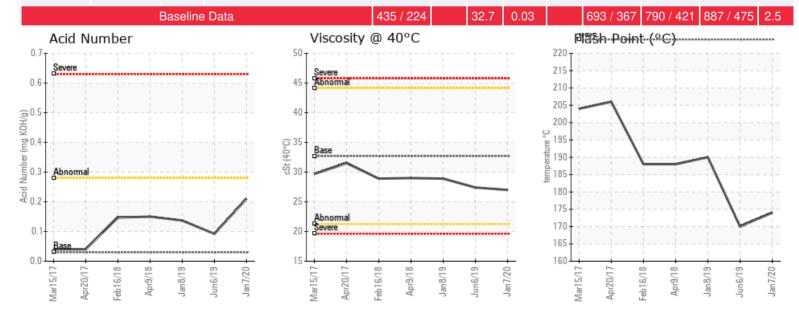
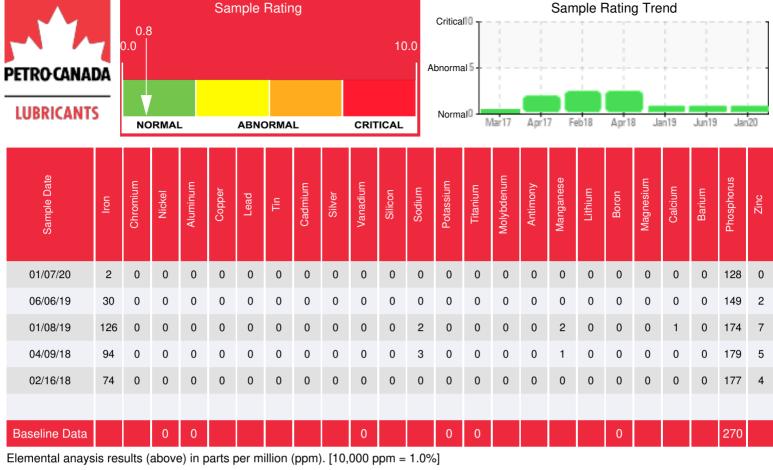
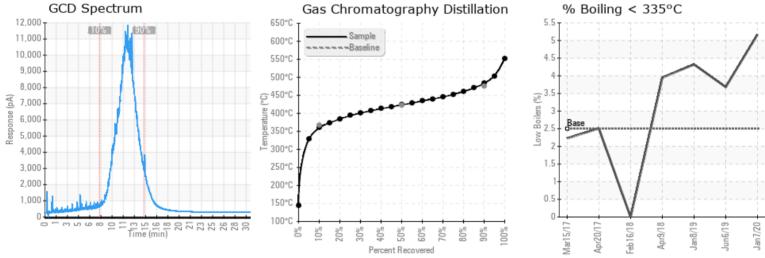
Sample Date	Received Date	Fluid Age	Sample Location	Flash Point (COC)	Water (KF)	Viscosity (40°C)	Acid Number	Solids	GCD 10%	GCD 50%	GCD 90%	GCD % < 335°C
	mm/dd/yy			°F/°C	ppm	cSt	mg/KOH/ g	%wt	°F/°C	°F/°C	°F/°C	%
01/07/20	09/17/20	48m	Strainer	345 / 174	14.2	27.0	0.21	0.149	679 / 359	794 / 423	901 / 483	5.17
06/06/19	06/18/19	0m		338 / 170	18.1	27.4	0.092	0.036	685 / 363	794 / 424	904 / 485	3.68
01/08/19	01/21/19	0m		374 / 190	15.0	28.9	0.137	0.096	667 / 353	771 / 411	874 / 468	4.32
04/09/18	04/20/18	17m		370 / 188	26.7	29.0	0.150	0.077	674 / 356	780 / 416	884 / 473	3.95
02/16/18	03/07/18	28m		370 / 188	15.1	28.9	0.147	0.072	691 / 366	781 / 416	888 / 475	0.00

Recommendation: Sample was submitted 9 months after taking. Flash point is lower than normal but slightly higher than past sample. Low boilers are rising as well, if system can be vented (may have been already) it should be done. Timely sample submissions yield more relevant data.

nistoncal Comments
06/06/19	The viscosity has been slowly declining and so is the flash point. We suggest to vent the low boilers and replace the volume lost by adding fresh oil in the expansion tank. COC Flash Point is abnormally low.
01/08/19	The results are almost identical to the satisfactory results from 6 months ago. No action needed at this time besides re-sampling in about 6-9 months time. COC Flash Point is marginally low.
04/09/18	The results are almost identical to the satisfactory results from a couple months ago. No action needed at this time besides re-sampling in about 6-9 months time. COC Flash Point is marginally low.
02/16/18	The viscosity dropped 10% in 9 months. it is still within normal limits but the drop is also felt in the drop in flash point. We suggest to perform a venting of the fluid to release the light ends and replace the volume lost by adding fresh fluid. This will help keep the flash point strong and properties normal. COC Flash Point is marginally low.
