TFS H/O SYSTEM #1

Customer: PTRHTF10176	System Information	Sample Information
CERTAINEED ROOFING 100 CERTAINEED DR JONESBURG, MO 63351 USA Attn: Jeff Montgomery Tel: (952)261-9532 E-Mail: jeffrey.d.montgomery@saint-gobain.com	System Volume: 4462 gal Bulk Operating Temp: 553F / 289C Heating Source: Blanket: Fluid: PETRO CANADA CALFLO AF Make: FSE	Lab No: 02385847 Analyst: Joe Goecke Sample Date: 11/02/20 Received Date: 11/06/20 Completed: 11/11/20 Joe Goecke joe.goecke@petrocanadalsp.com

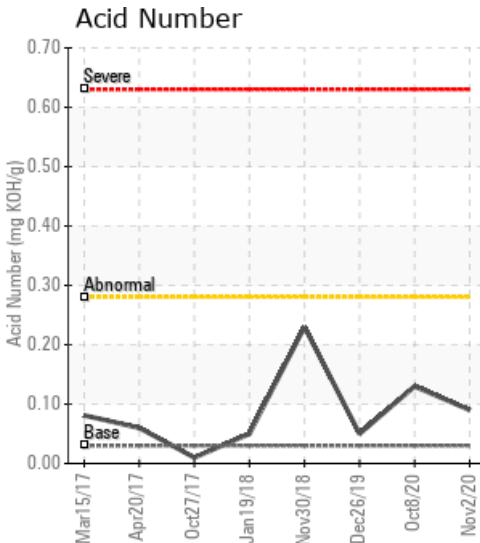
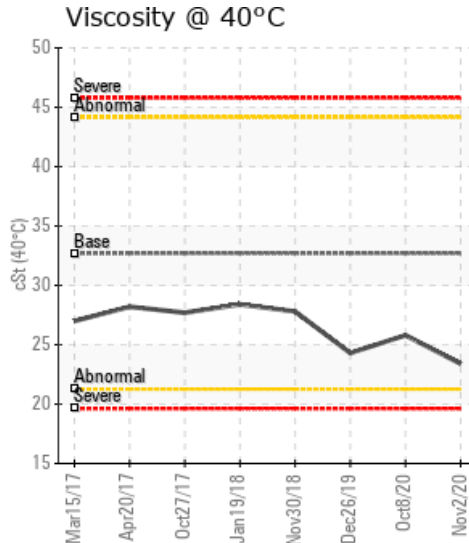
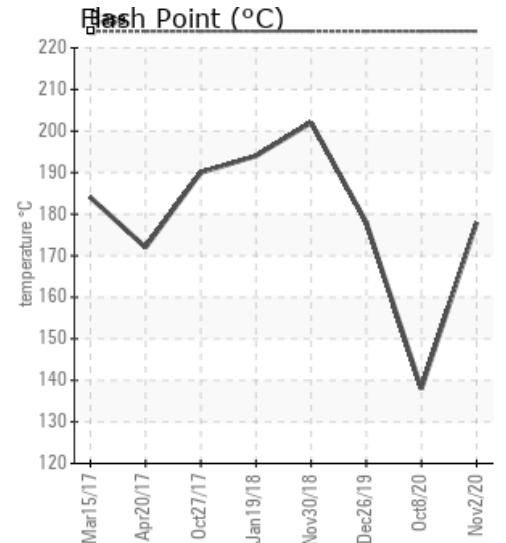
Sample Date	Received Date	Fluid Age	Sample Location	Flash Point (COC)	Water (KF)	Viscosity (40°C)	Acid Number	Solids	GCD 10%	GCD 50%	GCD 90%	GCD % < 335°C
	mm/dd/yy			°F/°C	ppm	cSt	mg/KOH/g	%wt	°F/°C	°F/°C	°F/°C	%
11/02/20	11/06/20	0y	Side Stream	352 / 178	11.0	23.4	0.09	0.090	665 / 352	792 / 422	901 / 483	7.03
10/08/20	10/15/20	4y	SIDE STREAM	280 / 138	17.5	25.8	0.13	0.092	664 / 351	792 / 422	901 / 483	7.08
12/26/19	09/17/20	4y	Filter	352 / 178	14.9	24.3	0.05	0.089	674 / 357	793 / 423	897 / 481	5.97
11/30/18	12/18/18	0y		396 / 202	13.8	27.8	0.23	0.054	683 / 362	791 / 422	897 / 480	3.65
01/19/18	01/26/18	2y		381 / 194	6.4	28.4	0.05	0.039	690 / 365	785 / 418	880 / 471	1.08
Baseline Data				435 / 224		32.7	0.03		693 / 367	790 / 421	887 / 475	2.5

Recommendation: Not much change in the light ends, but we did see a significant increase in flash point of 40 deg C. Viscosity dropped another 2 centistokes. Since the flash point has increased and we had a slight change in low boilers, I suggest continuing to run and resample next quarter with plans to change in next 90-180 days depending on next results.
